Inspectify Flag

Property Information

Home Type:	Single Family	Year Built:	1918
------------	---------------	-------------	------

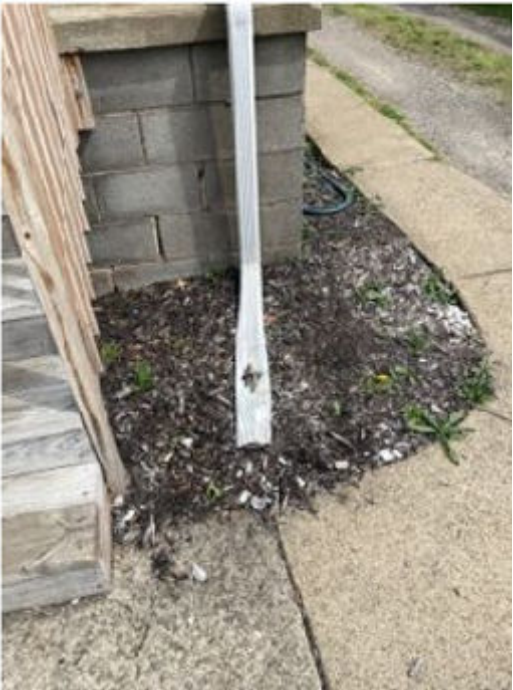
Repair	Downspouts had some visible damage , recommend repair/replacement of the damaged sections

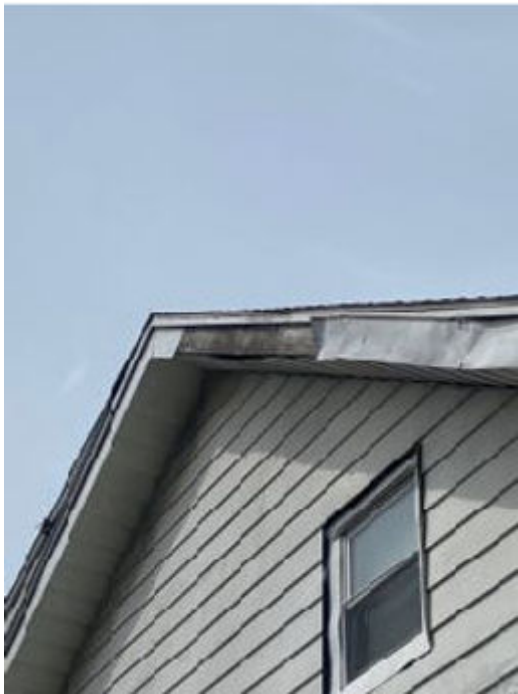
A section of fascia was missing. Repairs/replacement recommended at the affected area

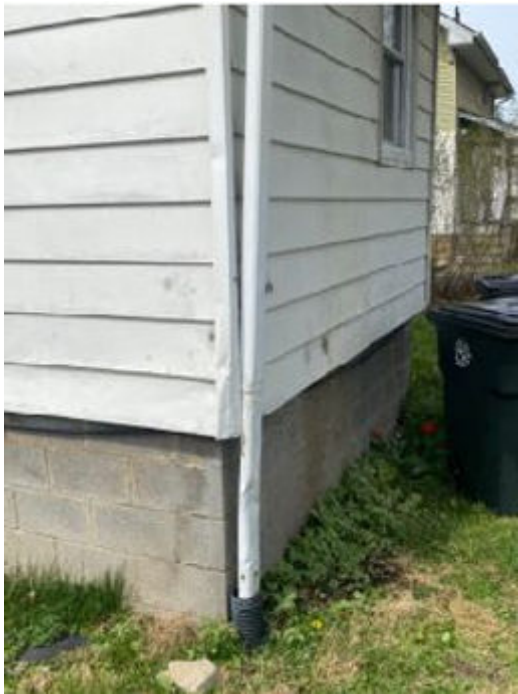
Downspouts had some visible damage , recommend repair/replacement of the damaged sections

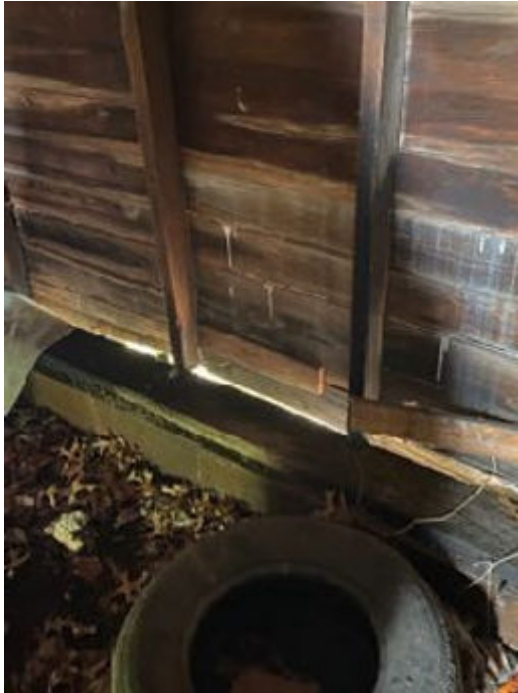
Missing siding at the garage is leaving the interior exposed to weather conditions and critters. Repair(s) recommended

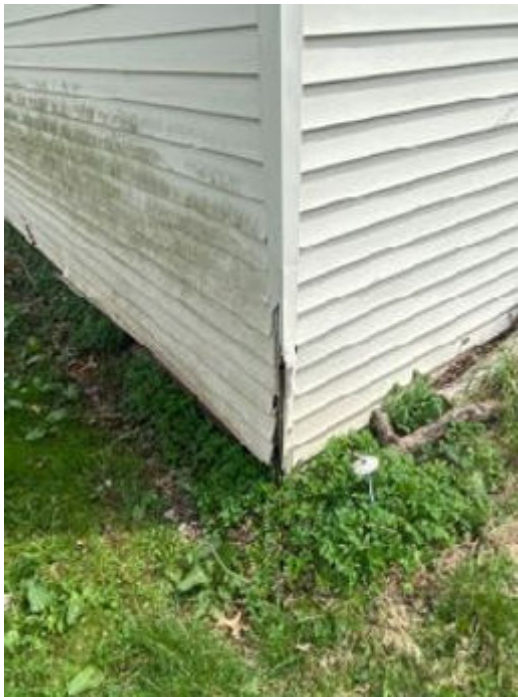
Garage trim had some damage recommend repair

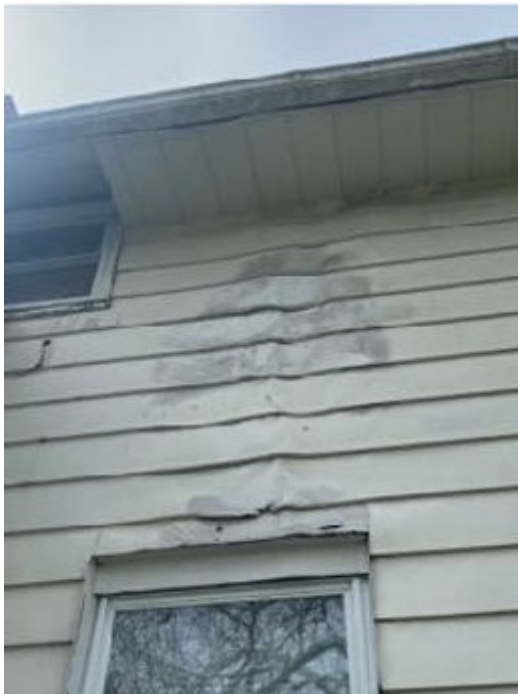
Siding had some damage, recommend repairing/replacing damaged sections

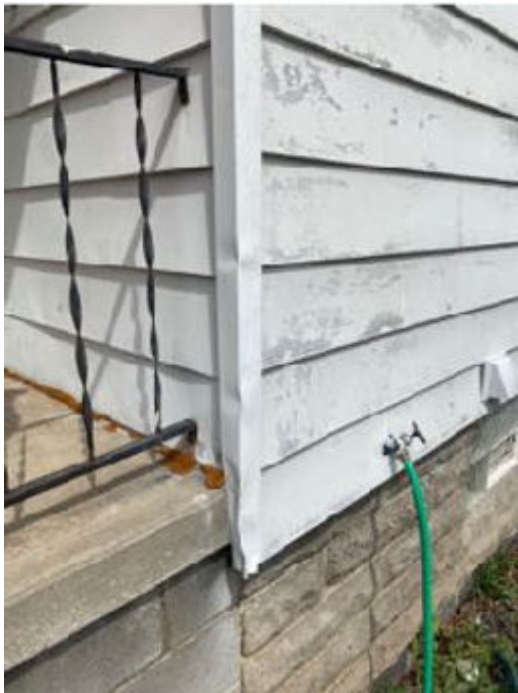
Recommend repair of damaged trim by a qualified contractor

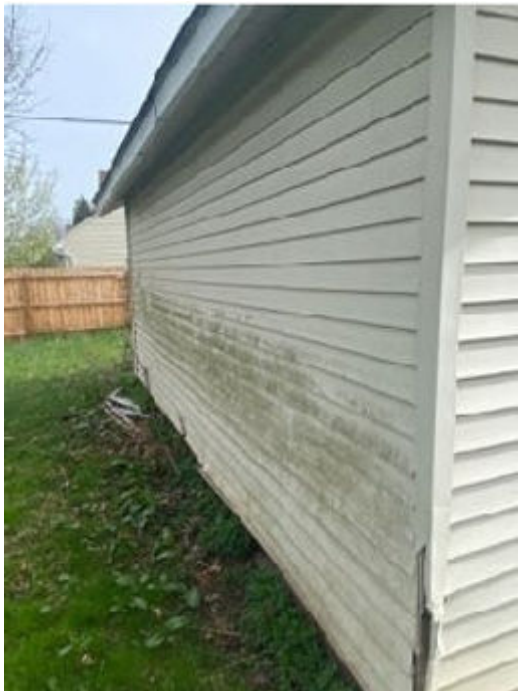
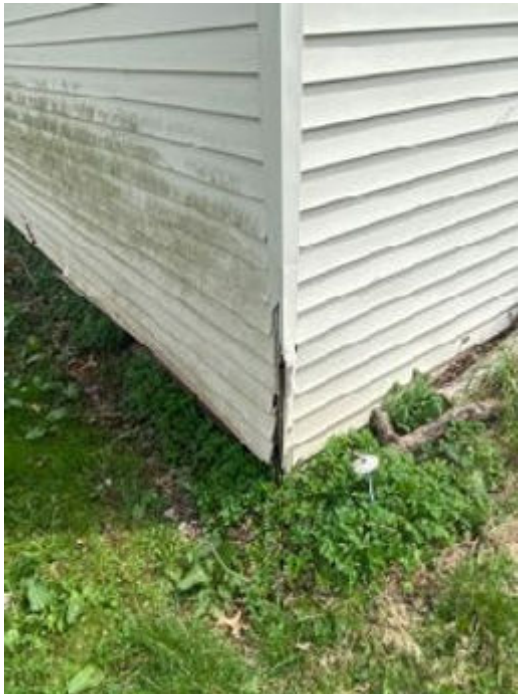
The garage siding has moss present. This should be considered a minor defect, power washing or removing the moss is recommended

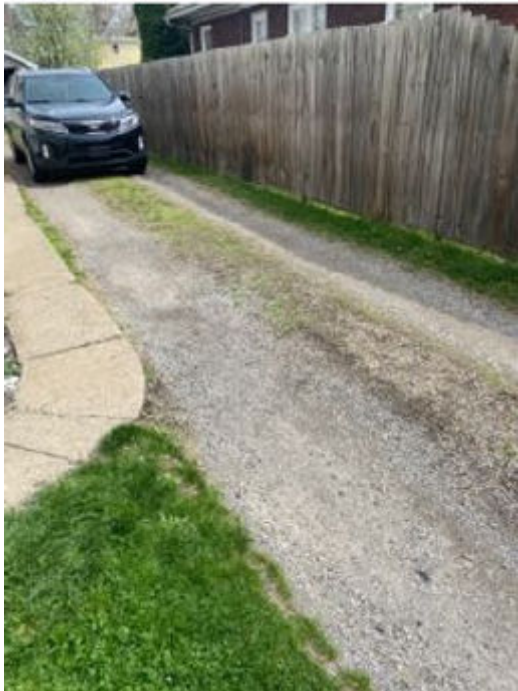
Driveway was in poor condition recommend repair and/or replacement

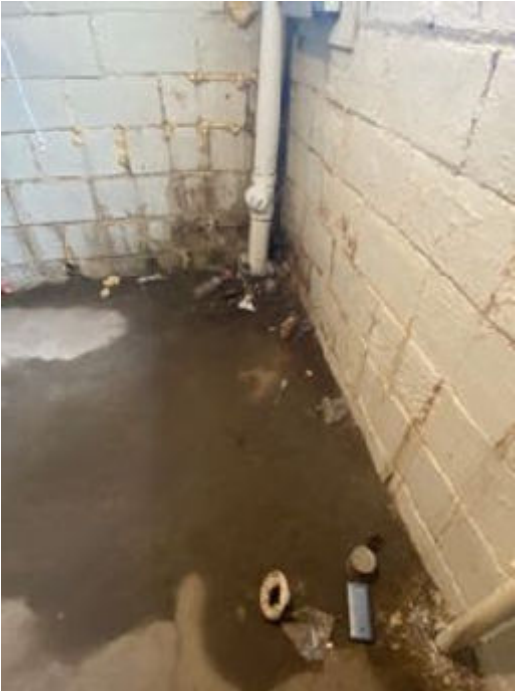
Repair	Foundation walls were showing efflorescence and some moisture. This should be considered common for basements in this climate that do not have a waterproofing system. Maintaining a proper soil pitch at the exterior perimeter of the foundation, as well as keeping the gutters & drain tiles clean will give rainwater its best opportunity to move away from the foundation. Informational item

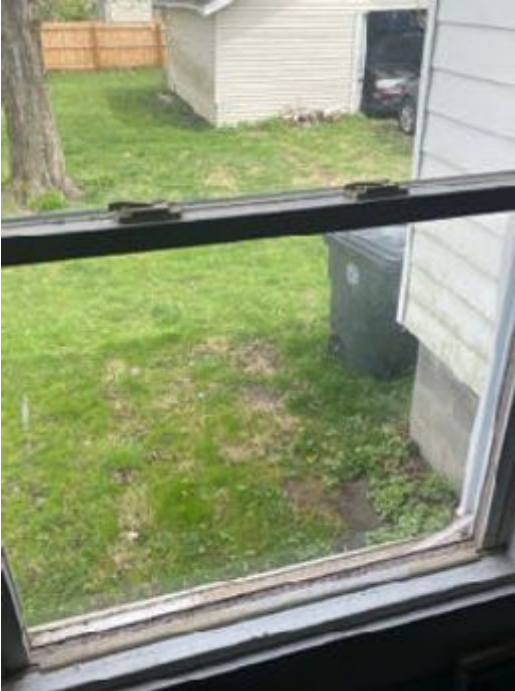
Repair	Broken/cracked glass at the window. Repairs/replacement recommended for safety considerations

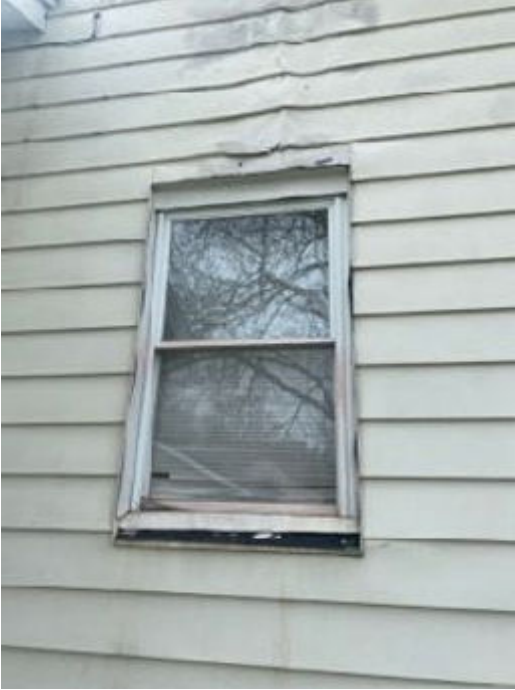
Repair	The rear window framing is damaged and missing trim. Further review from a qualified contractor is recommended

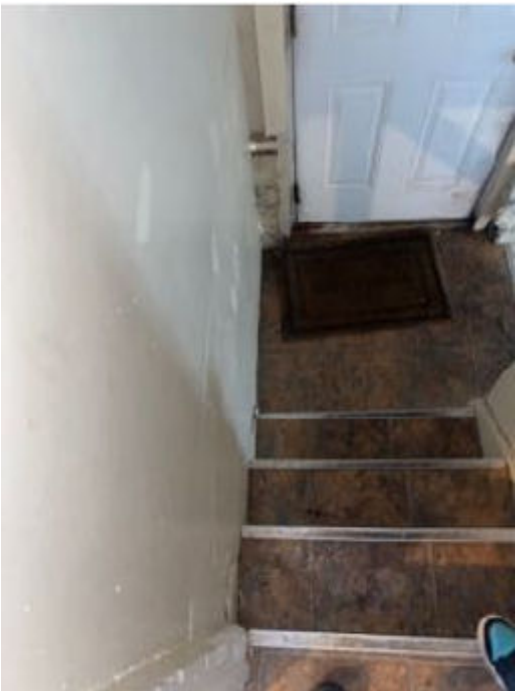
Repair	Handrail missing, potential safety issue. Recommend installing handrail

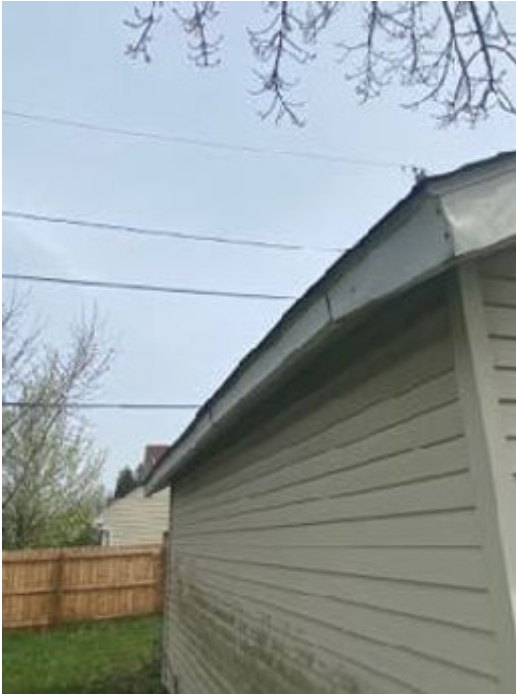
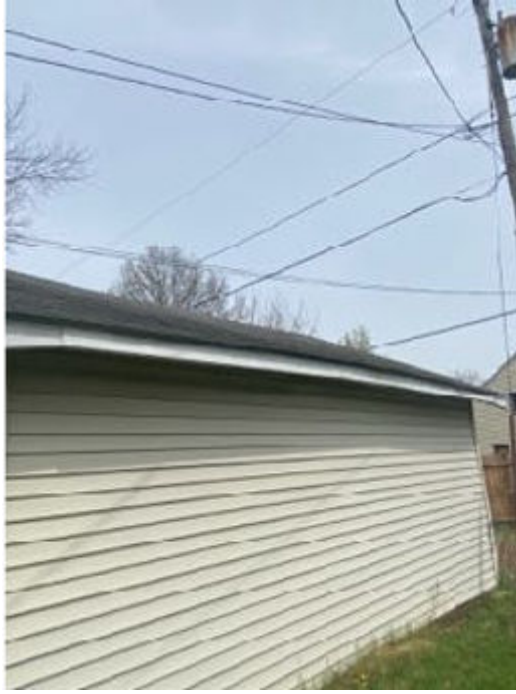
Repair	Recommend installing gutters and/or downspouts at the garage

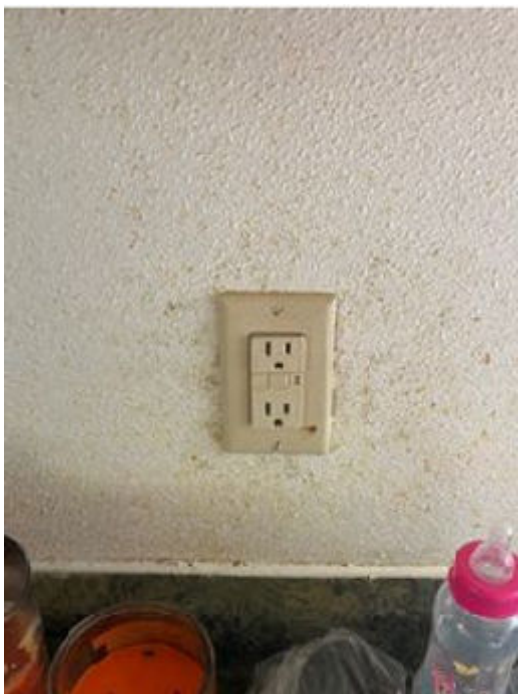
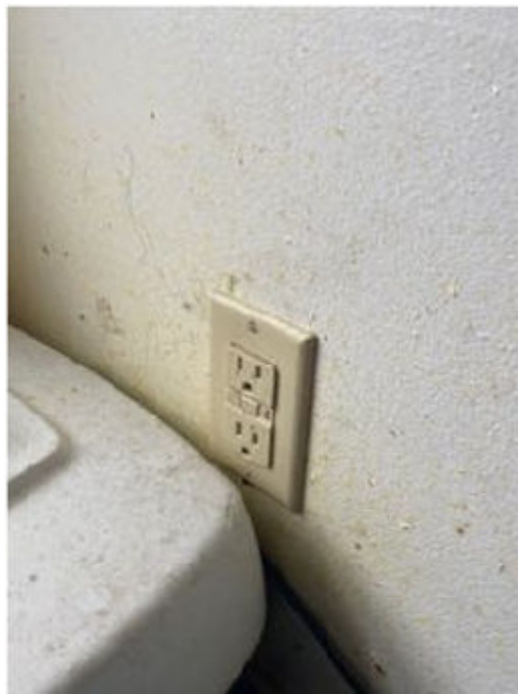
Outlets at the kitchen wall and counter are not functional. Repairs/replacement recommended

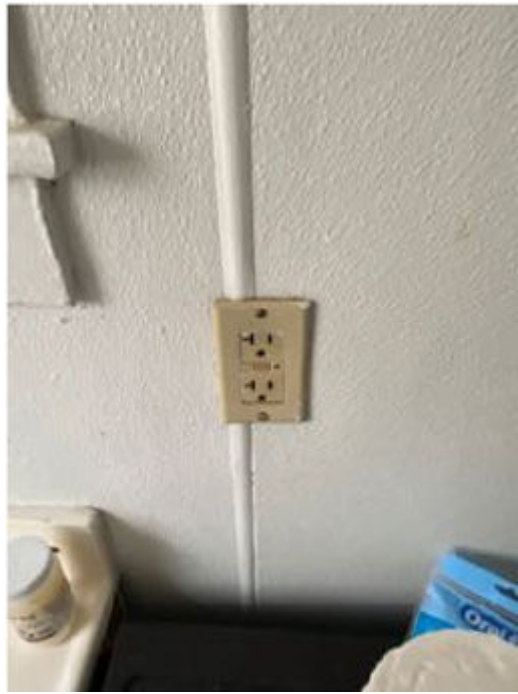
The bathroom outlet was not functional. Repairs/replacement recommended

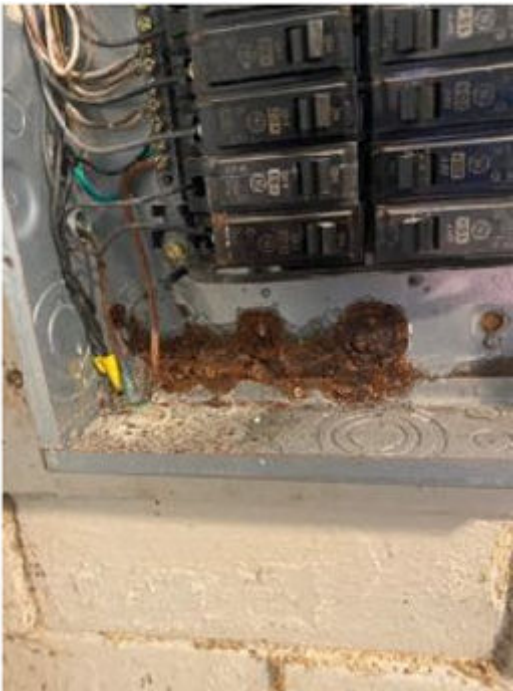
Evidence of rust in panel. Further review from a licensed electrician is recommended

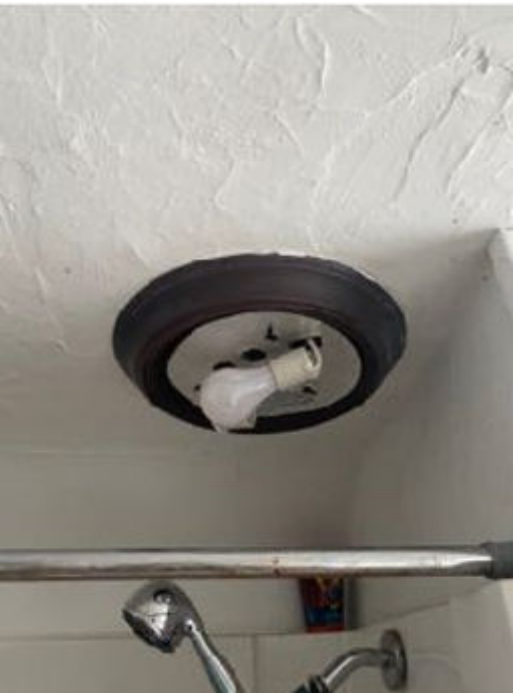
The bathroom overhead lighting was not functional. Repairs/replacement recommended

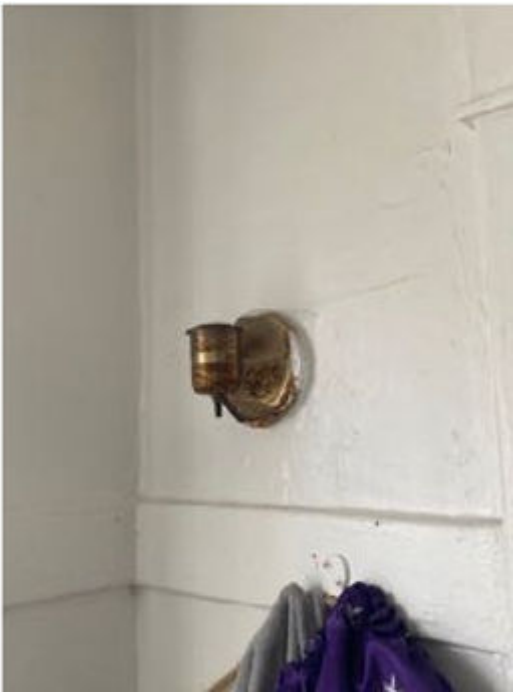
The bathroom overhead lighting was not functional. Repairs/replacement recommended
