637 Woodbine Ave SE, Warren, OH 44483, USA

Summary

Repair Estimate

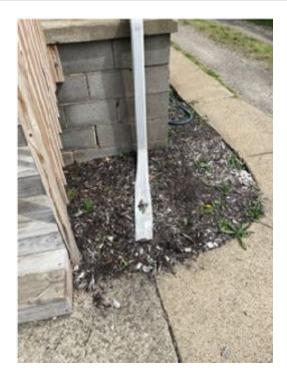
Downspouts had some visible damage, recommend repair/replacement of the damaged sections

Replace section(s) of gutters

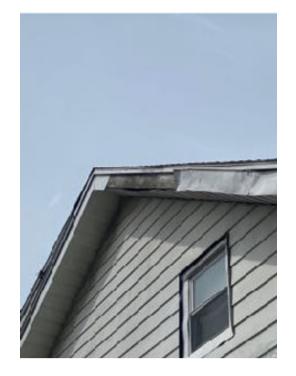
A section of fascia was missing. Repairs/replacement recommended at the affected area

Repair or replace damaged sections of the fascia

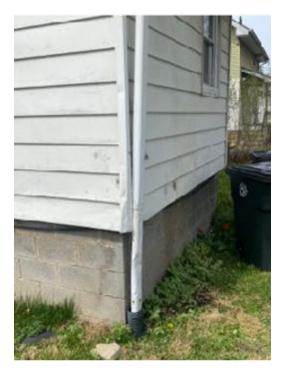
Downspouts had some visible damage , recommend repair/replacement of the damaged sections

Replace section(s) of gutters \$400 - \$600

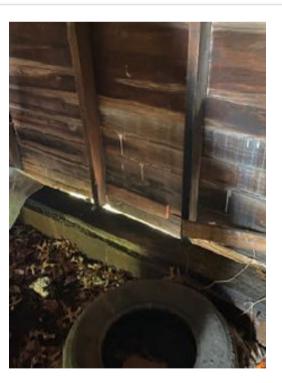
Missing siding at the garage is leaving the interior exposed to weather conditions and critters. Repair(s) recommended

Install new siding

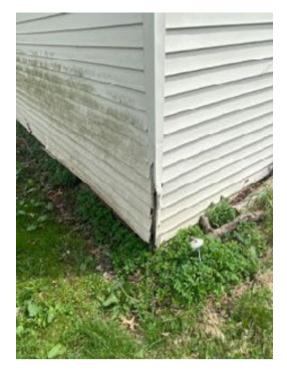
Garage trim had some damage recommend repair

Repair or replace trim and paint to patch

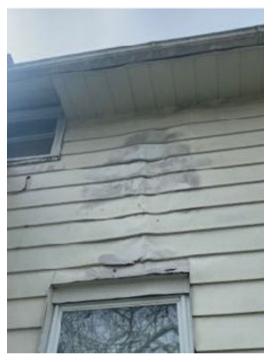
Siding had some damage, recommend repairing/replacing damaged sections

Replace damaged siding and paint to match

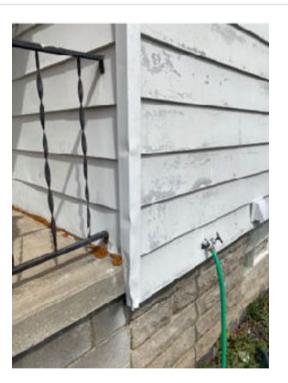
Recommend repair of damaged trim by a qualified contractor

Repair or replace trim and paint to patch

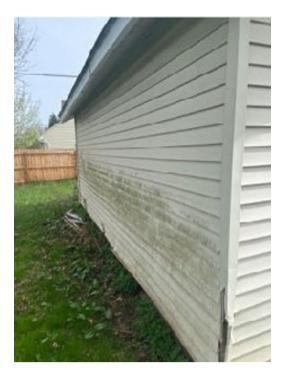
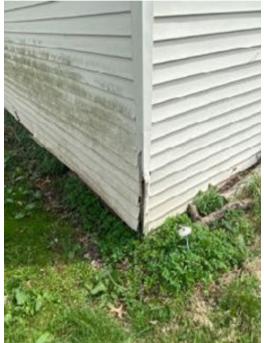
The garage siding has moss present. This should be considered a minor defect, power washing or removing the moss is recommended

Remdiate \$400 - \$600 or remove

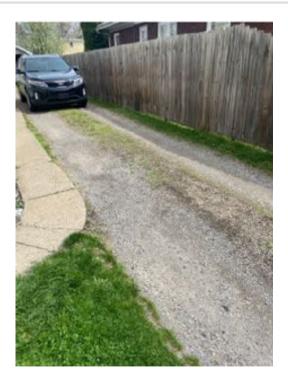
Driveway was in poor condition recommend repair and/or replacement

Seal or repair concrete cracks or damage \$160 - \$240

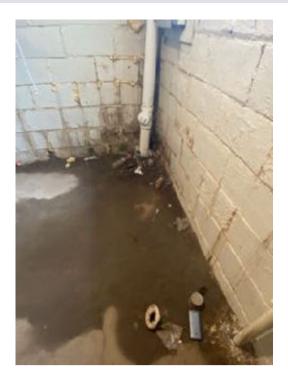
Foundation walls were showing efflorescence and some moisture. This should be considered common for basements in this climate that do not have a waterproofing system. Maintaining a proper soil pitch at the exterior perimeter of the foundation, as well as keeping the gutters & drain tiles clean will give rainwater its best opportunity to move away from the foundation. Informational item

Clean
efflorescence,
seal, and
evaluating
where
moisture is
coming from

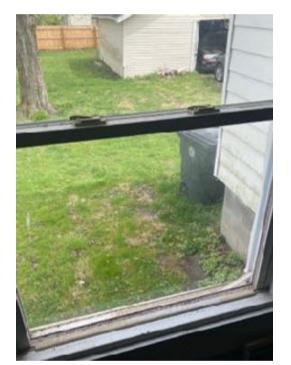
Broken/cracked glass at the window. Repairs/replacement recommended for safety considerations

Replace window

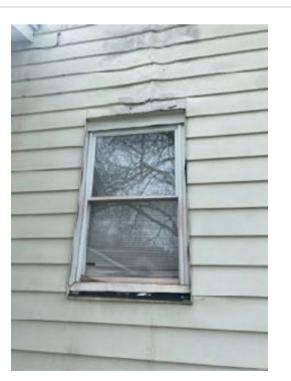
The rear window framing is damaged and missing trim. Further review from a qualified contractor is recommended

Repair or replace trim \$100 - \$150

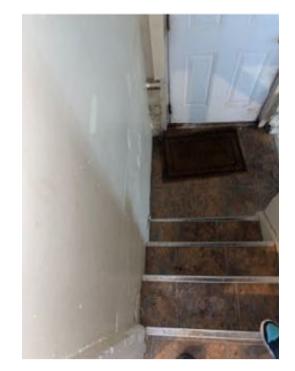
Handrail missing, potential safety issue. Recommend installing handrail

Railing \$ needs to be installed

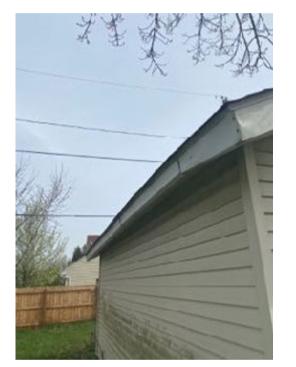
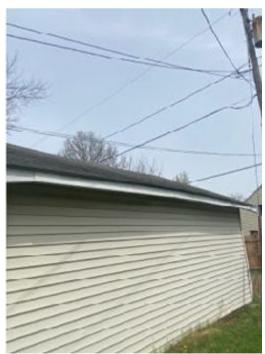
Recommend installing gutters and/or downspouts at the garage

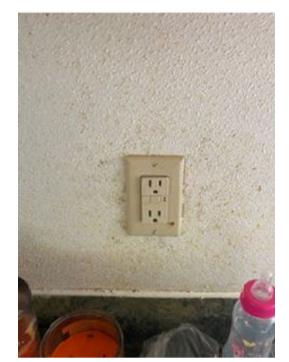
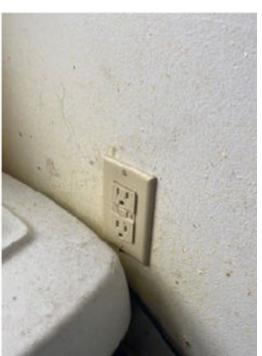
Outlets at the kitchen wall and counter are not functional. Repairs/replacement recommended

Repair or replace outlet

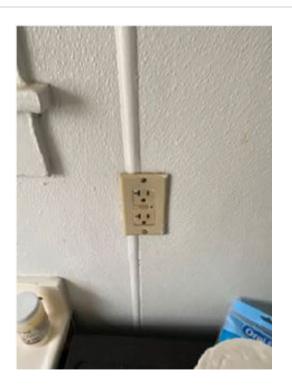
The bathroom outlet was not functional. Repairs/replacement recommended

Repair or replace outlet

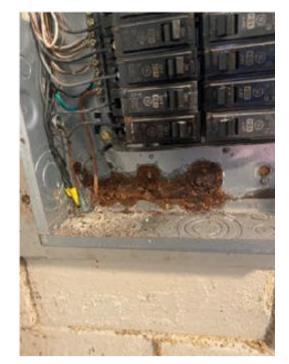
Evidence of rust in panel. Further review from a licensed electrician is recommended

Repair or replace breakers

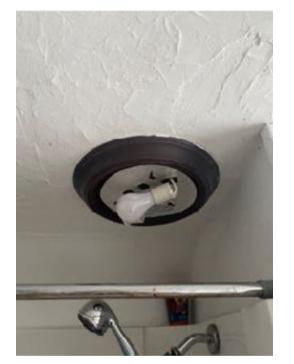
The bathroom overhead lighting was not functional. Repairs/replacement recommended

Repair \$

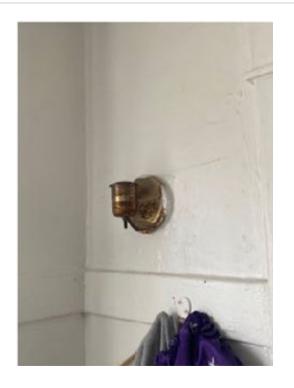
The bathroom overhead lighting was not functional. Repairs/replacement recommended

Repair light \$70 - \$110
