Inspectify Flag

Repair Estimate

Property Information

Home Type:	Single Family
Year Built:	1854
Roof Type:	Asphalt
Roof Age:	15 To 25 Years Old
Construction Type:	Wood Frame
Heating Energy Source:	Gas
Heating Type:	Forced Air Furnace
Electrical Branch Wiring:	Romex
Panel Rating:	100 Amp

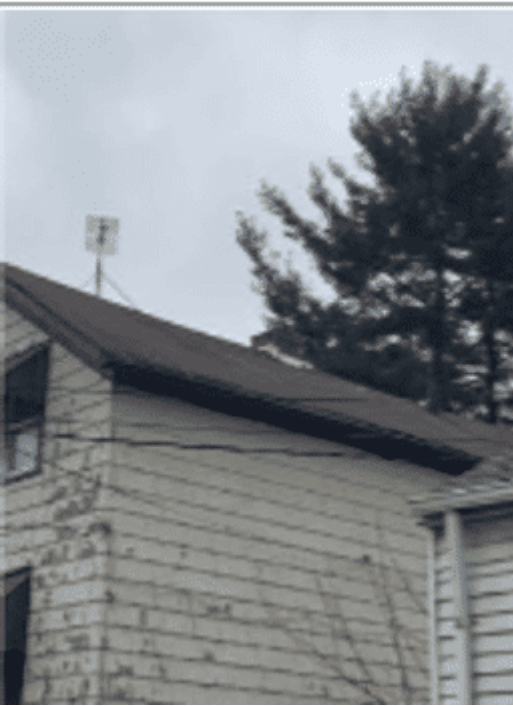
Repair	Recommend installing rain cap & screen

Install a spark/rain cap	\$320 - \$480

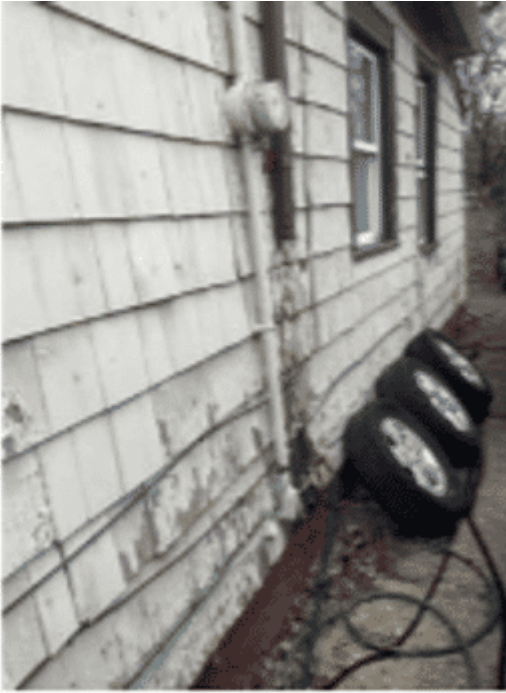
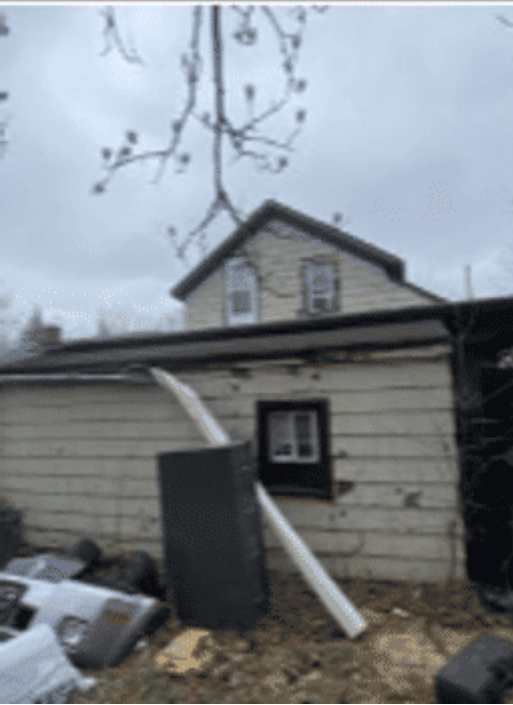
Repair	Gutters on only a portion of the house,

Replace section(s) of gutters	\$400 - \$600

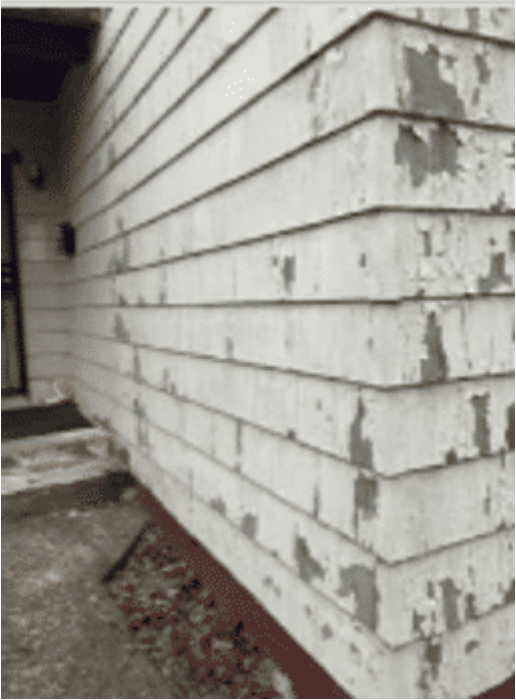
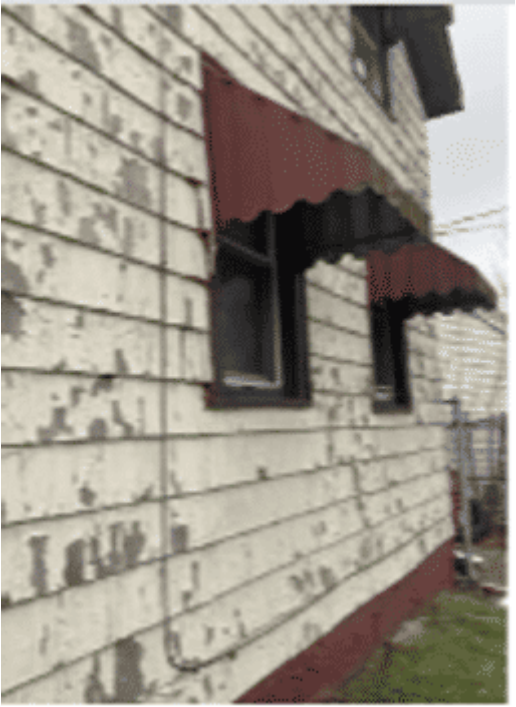
Repair	Siding had some damage, recommend repairing/replacing damaged sections. -flaking paint at the siding is in need of scraping and painting maintenance

Paint exterior section(s)	\$1,200 - \$1,800

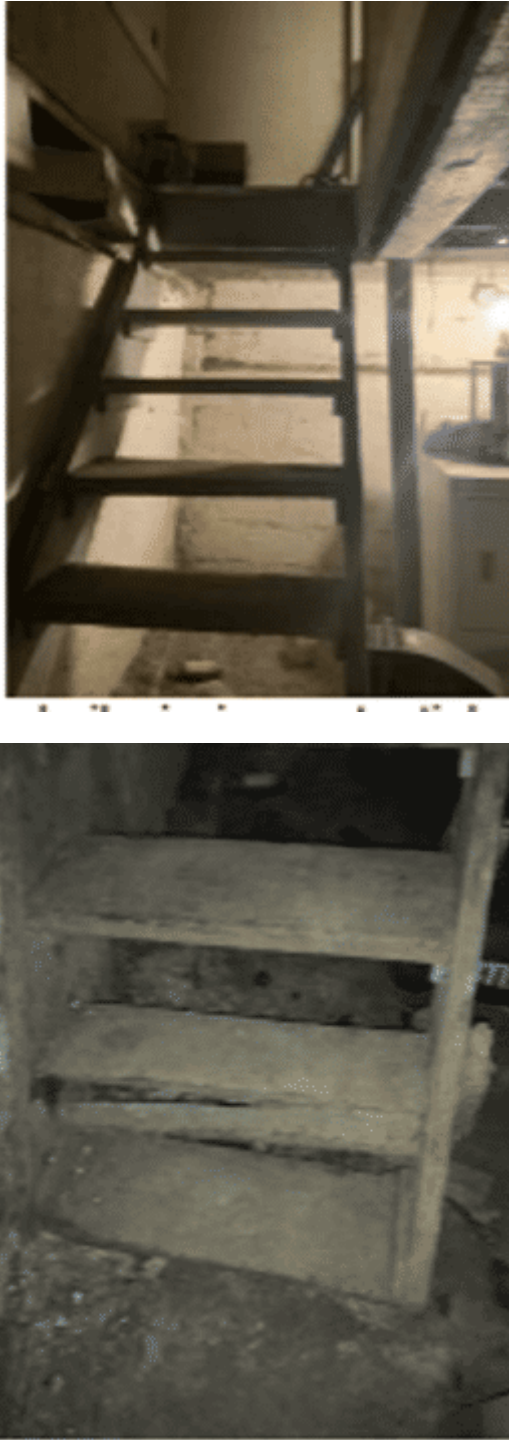
Repair</div>	Handrail missing, potential safety issue. Recommend installing handrail. -damaged treads at the basement stairs were in need of repairs/replacement

Railing needs to be installed	\$400 - \$600
<div>

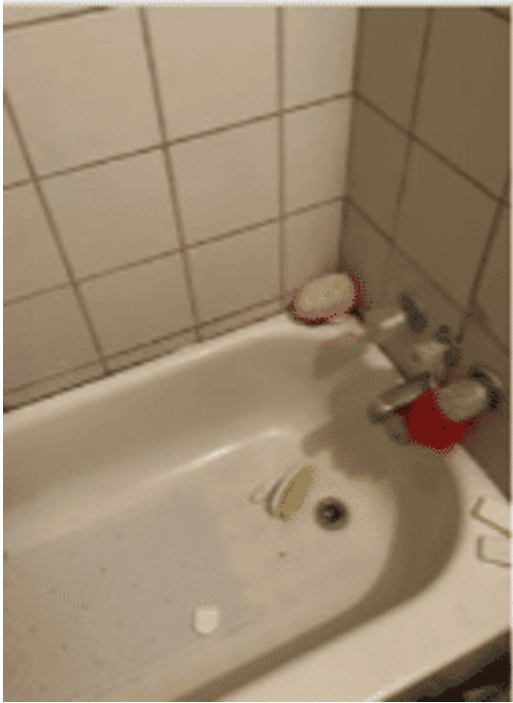
Monitor</div>	Caulk or grouting recommended in tub area

Caulk shower enclosure	\$120 - \$180

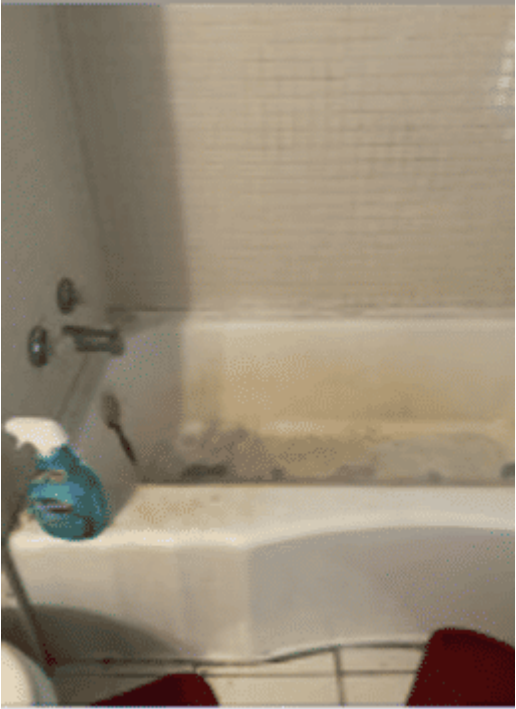
Monitor</div>	Aulk or grouting recommended in tub area

Caulk shower enclosure	\$40 - \$60
<div>

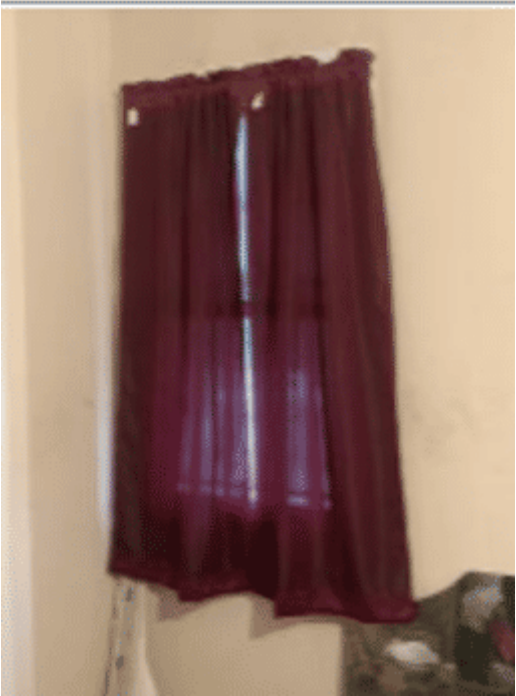
Repair</div>	Window at the bedroom does not stay open. Repair(s)/replacement recommended for safety considerations

Replace window hardware	\$200 - \$300
<div>

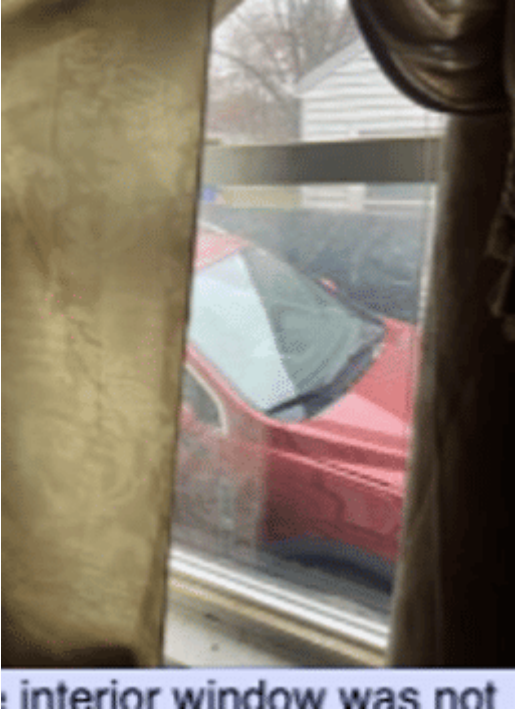
Repair</div>	The interior window was not functional. Repairs/replacement recommended

Repair or replace sash springs	\$200 - \$300

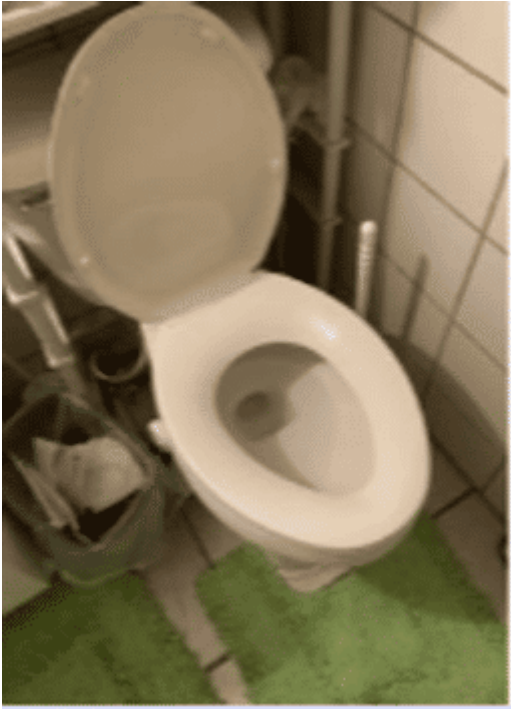
Repair	Toilet bowl is loose recommend repair

Re-attach toilet and caulk at base	\$240 - \$360

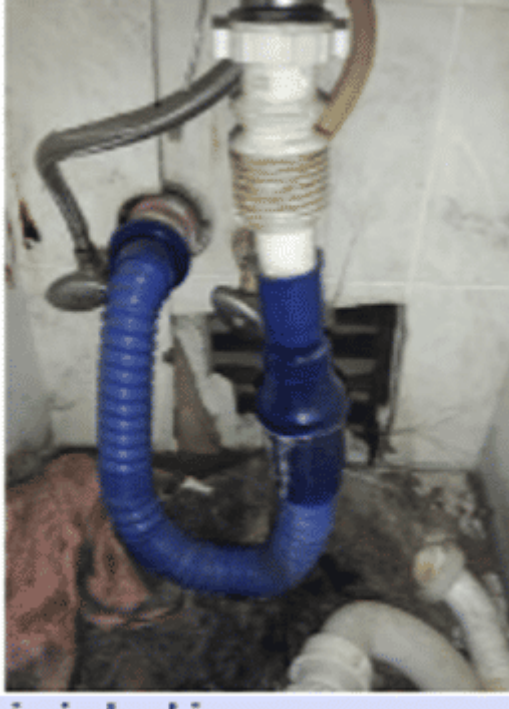
Repair	Drain is leaking - recommend repair and/or replacement

Replace flex drain	\$140 - \$210

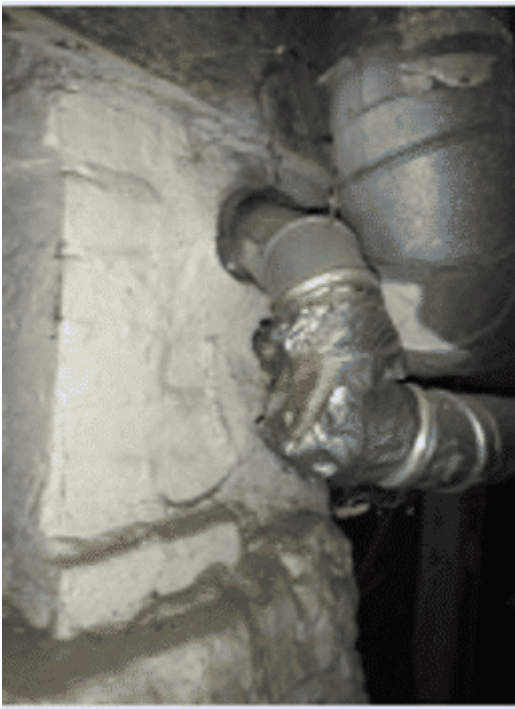
Repair	He water heater exhaust pipe is damaged and has holes. Repairs/replacement recommended

Repair or install water heater flue	\$100 - \$150

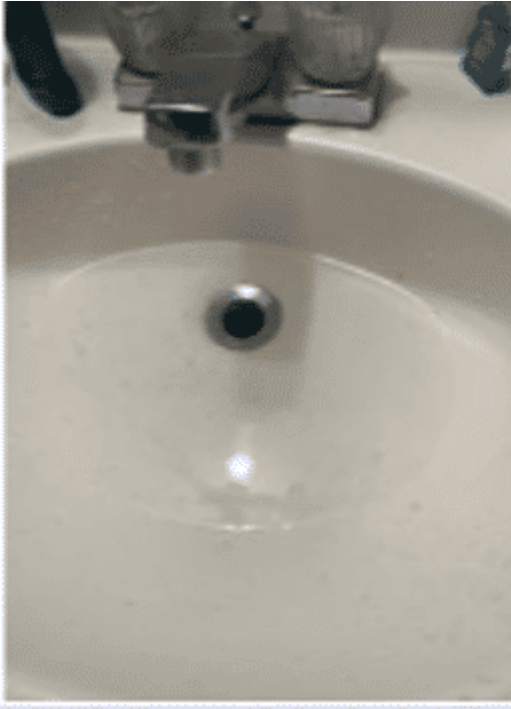
Monitor	The bathroom sink drain showed sign of back-up, recommend repair

Clear clogged drain	\$160 - \$240

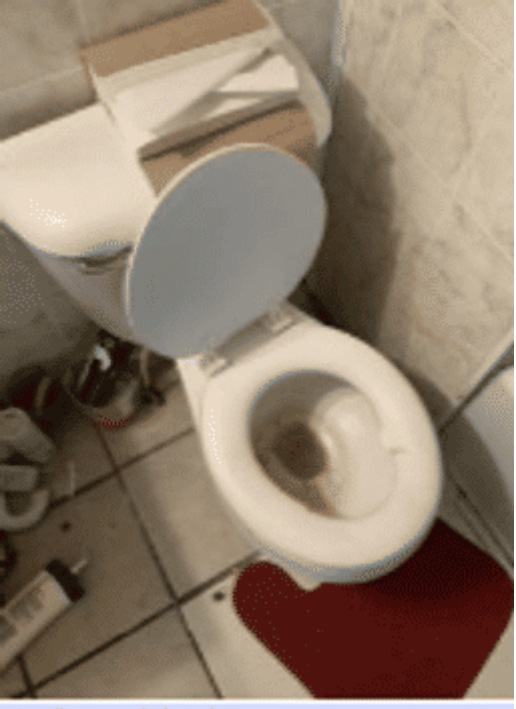
Repair	Toilet bowl is loose recommend repair

Re-attach toilet and caulk at base	\$240 - \$360

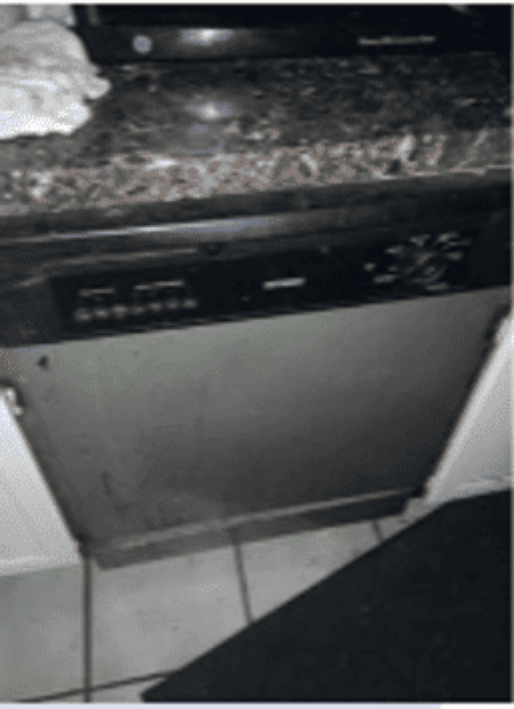
Repair	He dishwasher was not functional at the time of the inspection. Further review from a qualified handyman is recommended

Repair or replace dishwasher	\$440 - \$660

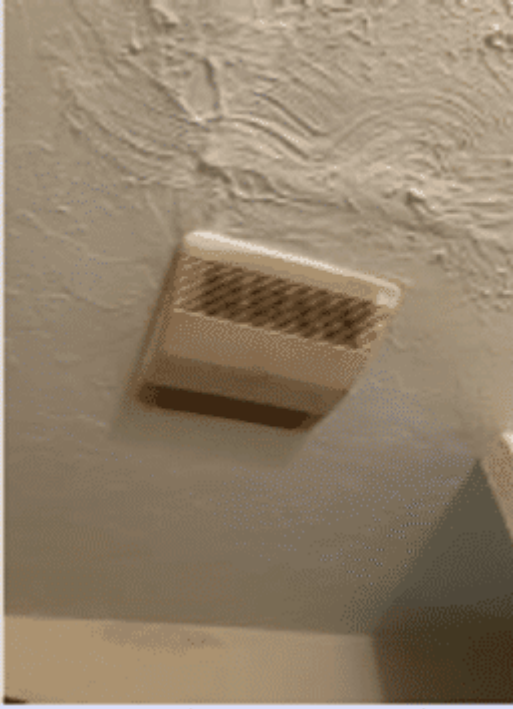
Repair	Recommend venting exhaust fan to exterior to allow the moist air from the shower/bath to vent to the exterior, opposed to the attic which can cause mold like growths. Repairs recommended for safety considerations

Extend vent to terminate outside	\$440 - \$660

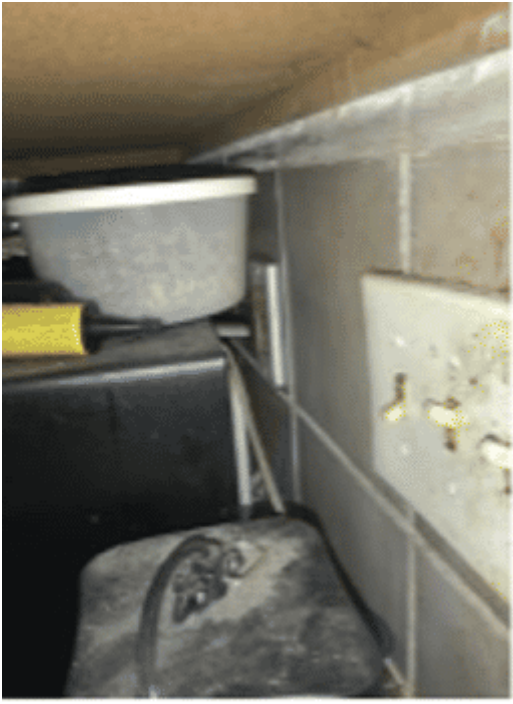
Repair	Ground-fault outlet was not operating properly, won't trip recommend replacing for safety considerations

Replace GFCI	\$100 - \$150
