# Property Inspection Group

## Inspection Report

1760 W 25th St, Los Angeles, CA 90018  
Inspection prepared for: Flyhomes  
Date of Inspection: 6/1/2020 Time: 10:00 AM  
Age of Home: 1902 Size: 2286 SqFt

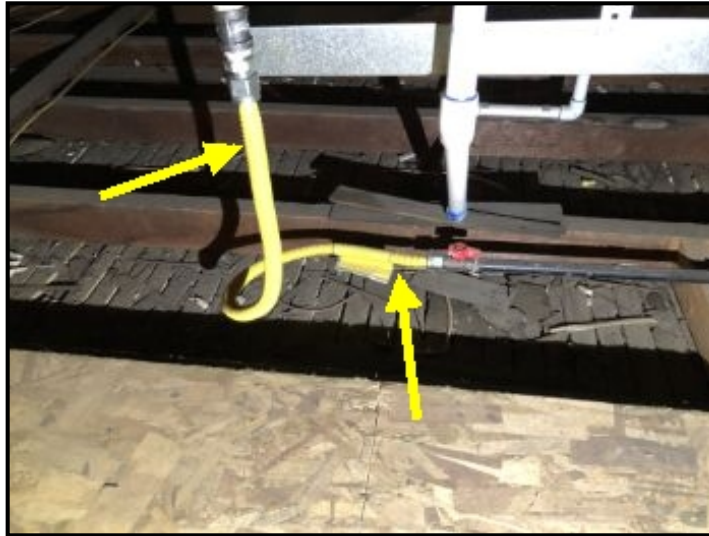
• The furnace gas line does not have a sediment trap. Note that industry standards state that a sediment trap is required, but the gas company claims that they are not needed since the gas is clean. What the sediment trap does is keep moisture and small particles from reaching the burner assembly. If the burner orifices get trash in them, the pilot or burner will not operate correctly. If the burner assembly is not operating correctly that could be dangerous. Recommend having a qualified contractor of the appropriate trade install sediment trap as required by standards.

No sediment trap

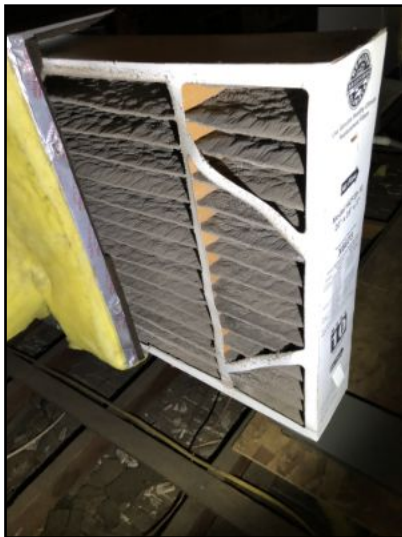
Location: Located adjacent the Forced Air Unit in the attic  
 Observations:  
 • The air filter should be inspected at least monthly and cleaned or replaced as required.  
 • The heating and cooling filter (located adjacent the forced air unit in the attic) is dirty. Recommend replacing the filter.

dirty filter

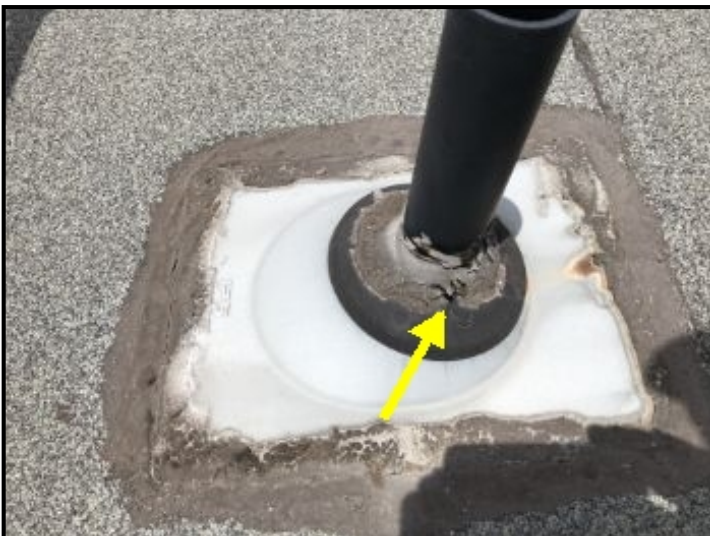
- Flashings are mastic covered, recommend re-sealing all through the roof vents and projections as a part of routine maintenance.
- **Improper installation of two ABS vent stacks found on the back field of the roof. The vents protrude through the roof without any proper flashing. Recommend having a qualified roofing contractor further evaluate and correct as needed.**

mastic cracking

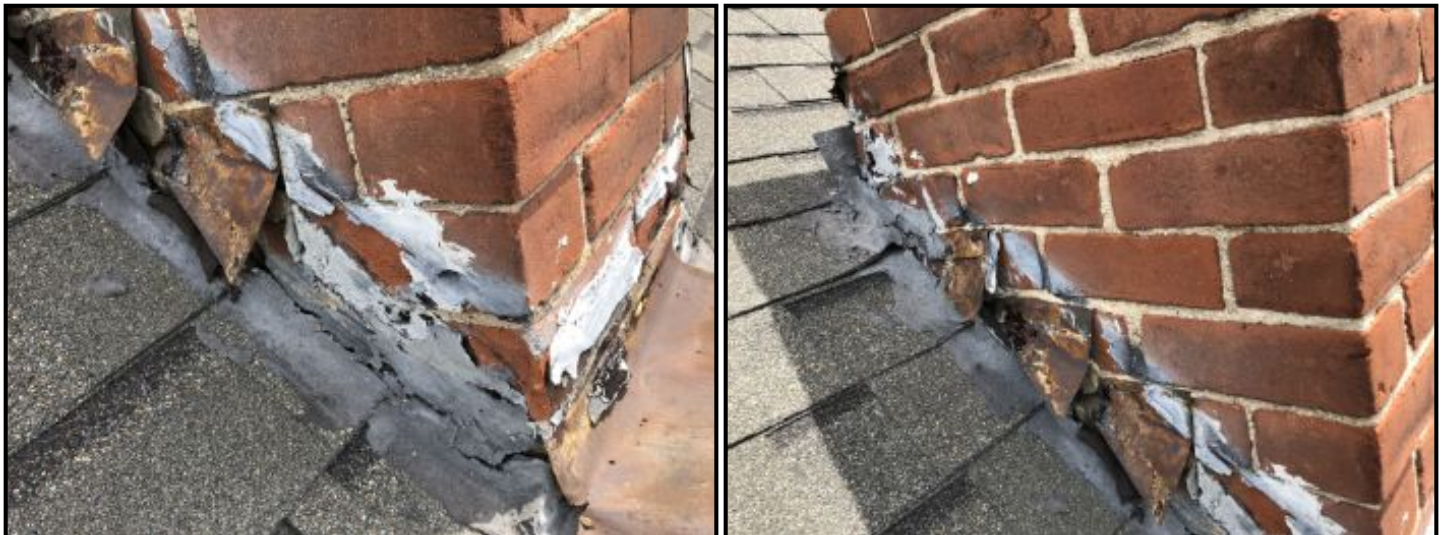
- The step flashing and counter flashing around the brick chimney has excessive damage.
- Recommend having a qualified chimney specialist further evaluate the condition of the chimney and make repairs as needed.

damaged chimney flashing

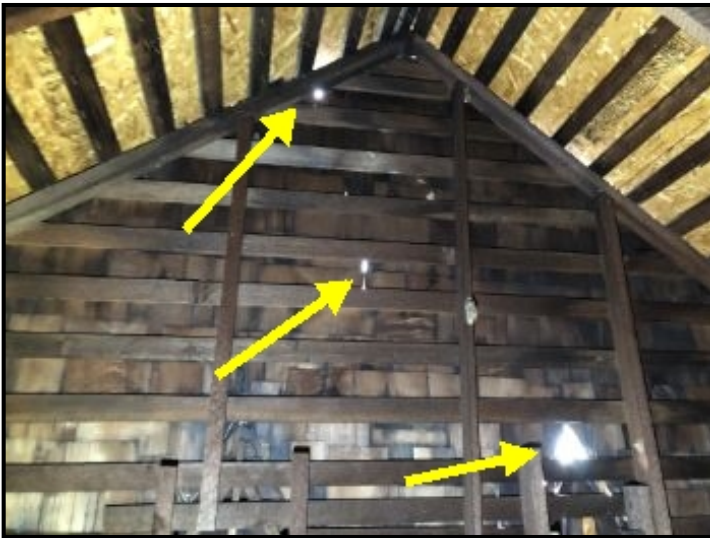
Visible gaps in the wood siding

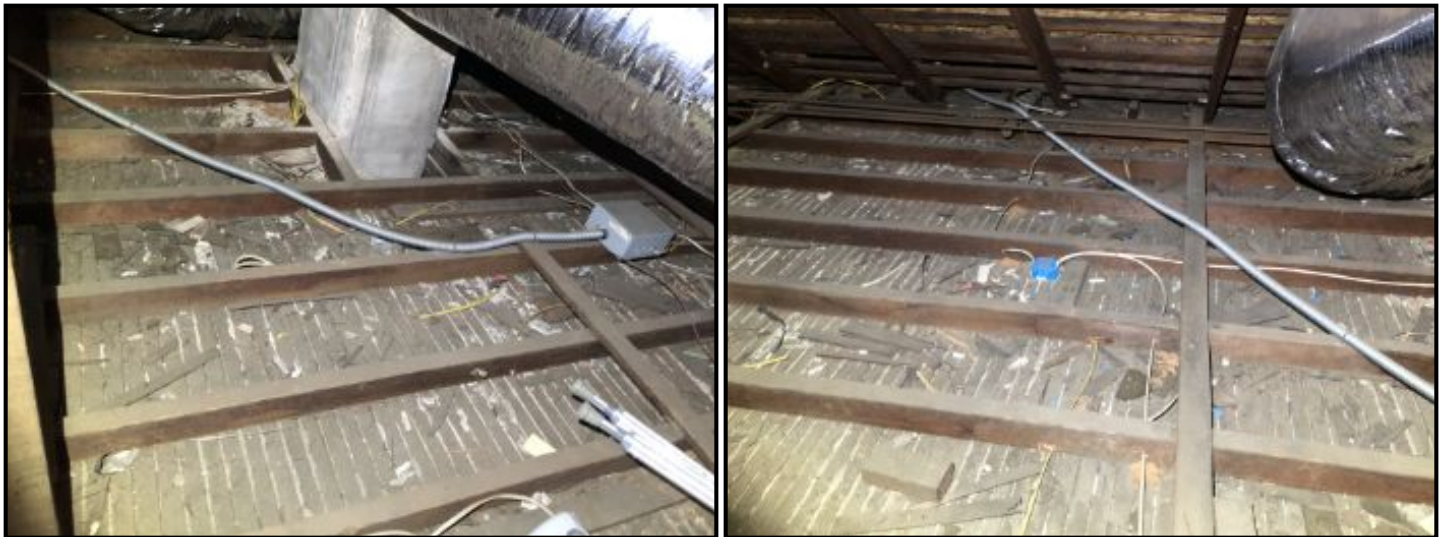
- The attic is without insulation. The lack of insulation may mean higher energy costs. Recommend having a qualified contractor add insulation.

no insulation on attic floor

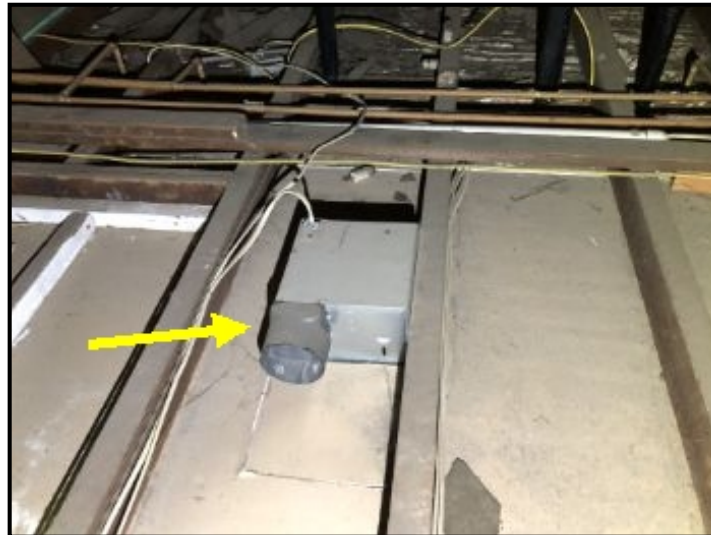
• The upstairs hall bathroom exhaust duct terminates in attic. Note that all exhaust ducts should terminate at the exterior of the home, never in the attic as this can lead to moisture issues. Recommend having a qualified contractor further evaluate and run the bathroom exhaust duct to the exterior as required.

bathroom exhaust terminates in attic

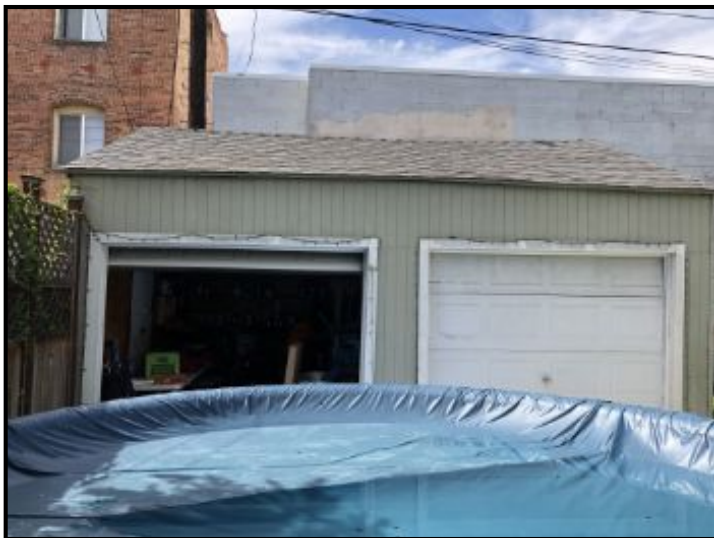
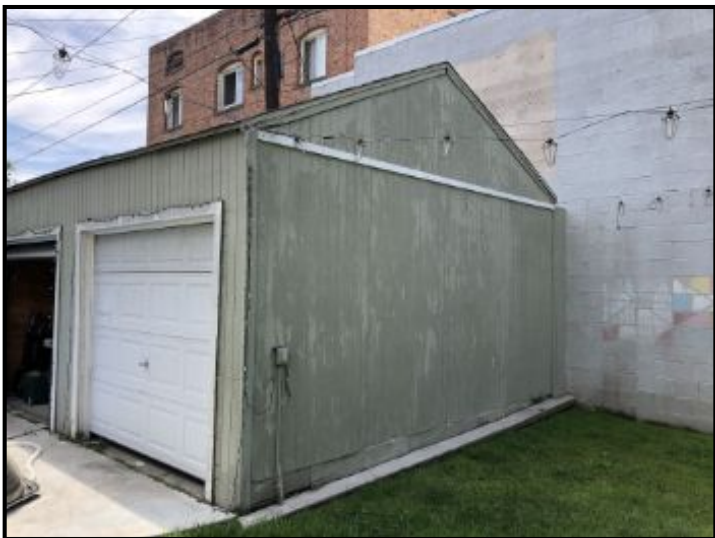
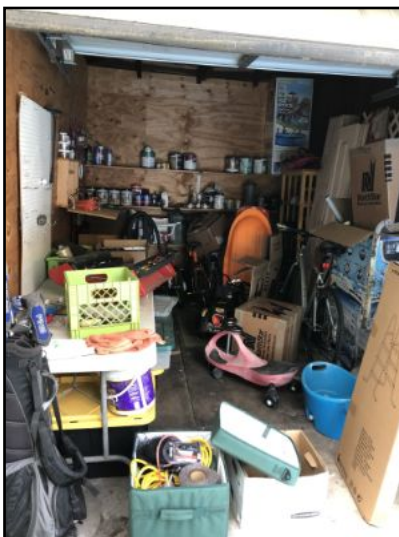
- There is very limited view of the garage due to belongings. Recommend inspecting the garage once the owner remove all belongings.

limited view

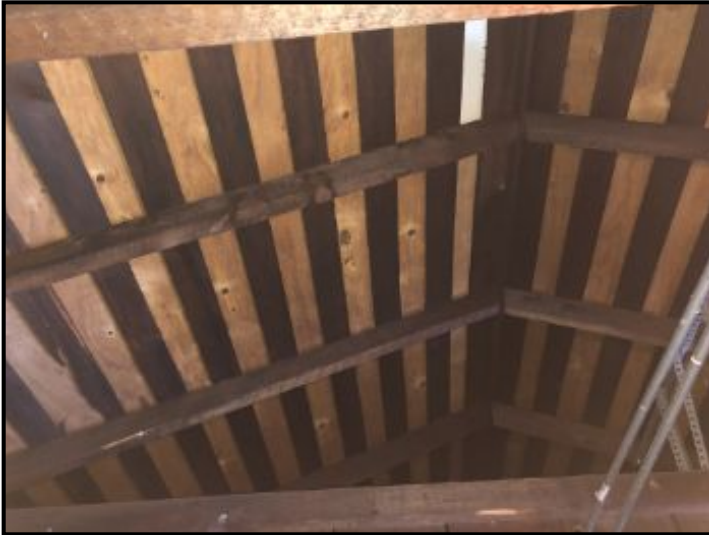
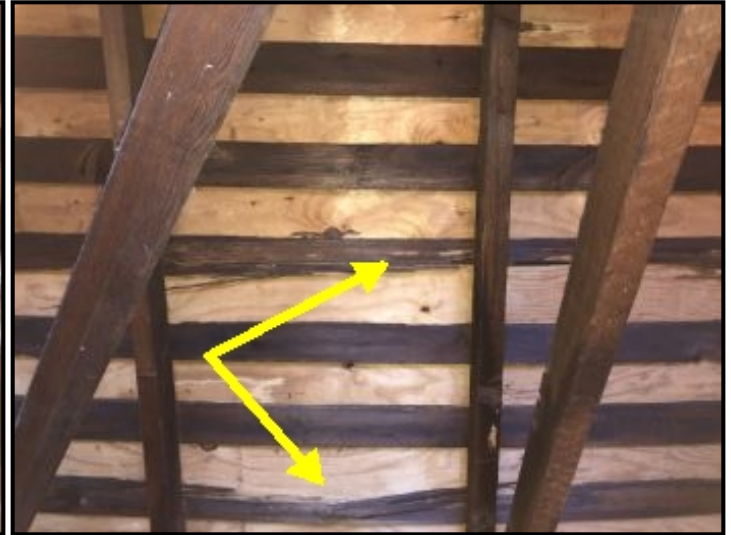
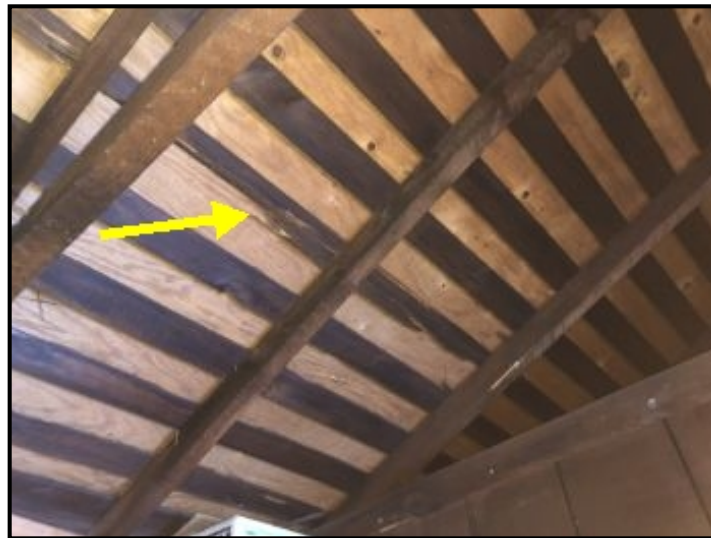
- Note that the original space sheathing has excessive deterioration at several slats at the garage roof. Due to condition, repair or replacement of damage space sheathing may be needed in the near future.

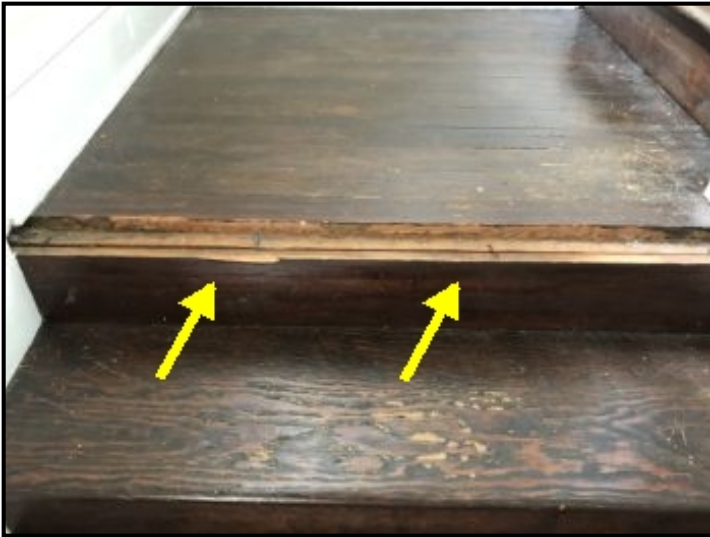
Observations:  
 • The older wood stairs are in need of minor repair. The stair at the front of the landing is damaged, and the bottom step is split. Due to condition repairs may be needed in the near future.

damaged stair at landing

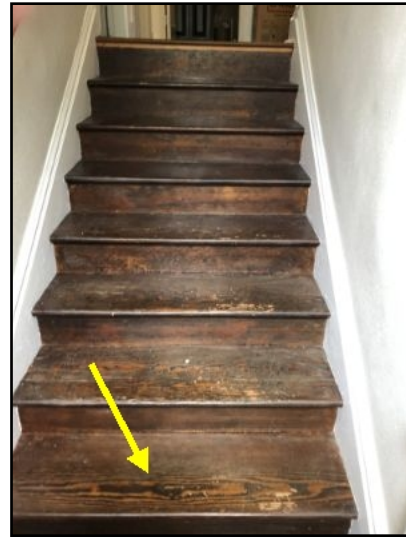
damaged bottom step

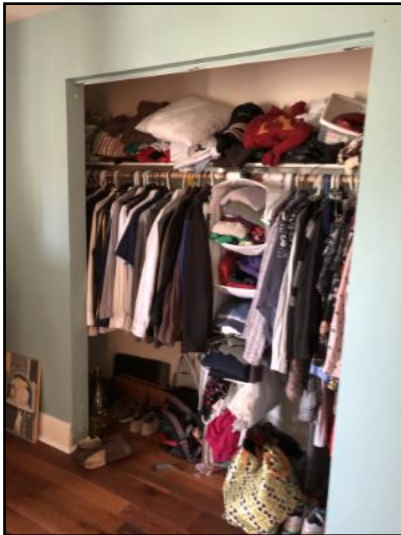
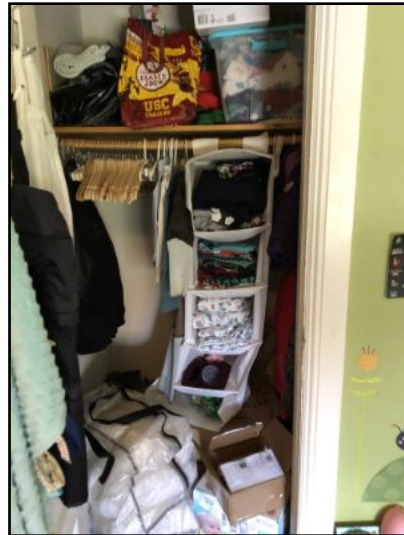
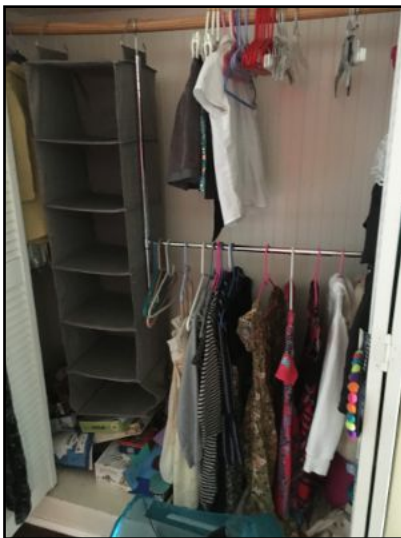
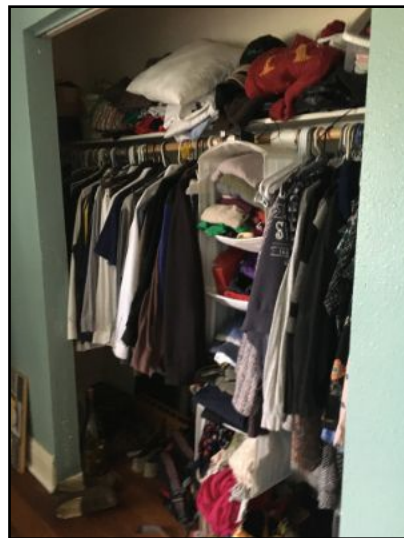
- The closet doors are missing in front right bedroom. Recommend having a qualified contractor replace.

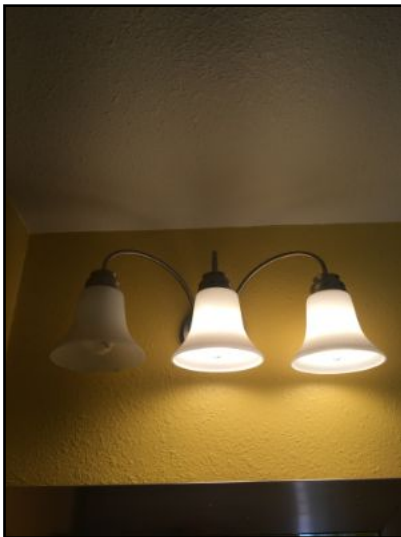
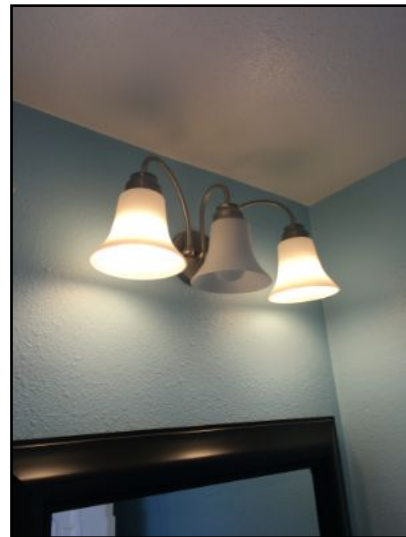
- Dead light bulbs in upstairs and downstairs bathroom vanity light fixtures. Checking/changing burned out/missing light bulbs is beyond the scope of this general home inspection. Recommend that light bulb(s) be replaced at any inoperable light and rechecked for proper operation before the close of escrow.

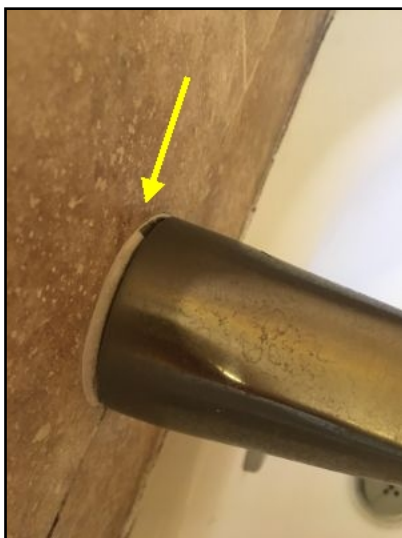
Page 36 Item: 11	Showers	<ul style="list-style-type: none"> <li>• The upstairs and downstairs bathroom tub/shower faucets are not flush to the wall, which may result in water escaping behind the shower enclosure. This can cause deterioration, wood rot, and possible mold of the wood framing behind the tub/shower.</li> <li>• The shower arm loose in upstairs and downstairs bathrooms. The loose arm can possibly cause damage to the supply line behind the shower enclosure and lead to leaks. Recommend having a qualified plumbing contractor further evaluate and repair as needed.</li> <li>• The upstairs bathroom tub/shower diverter valve may need replacement in the near future. When diverting the water from the tub faucet to the shower head, quite a bit of water continues to pour out from the tub's faucet. Recommend having a qualified contractor repair or replace as needed.</li> <li>• The caulking along the bottom of the shower stall has black staining. Due to condition, scraping and replacing of caulking may be needed in the near future.</li> <li>• The grout is cracking between the top of the tub and the shower tiles in the hallway bathroom. Due to condition, reapply of grout may be needed in the near future.</li> </ul>

gap at tub faucet

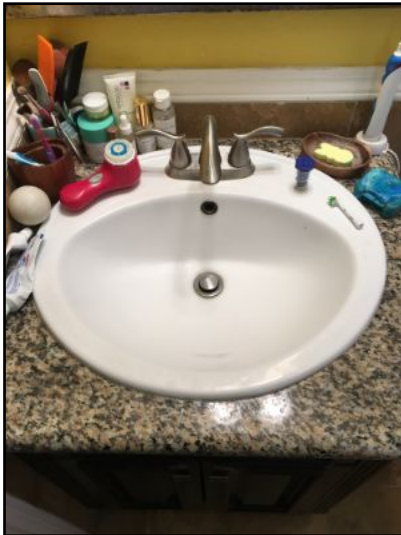
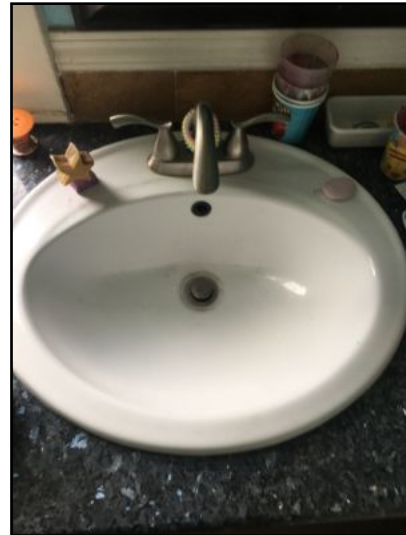
- Damaged caulking around sink in downstairs bathroom. Due to condition, scraping and reapplying caulking may be needed.

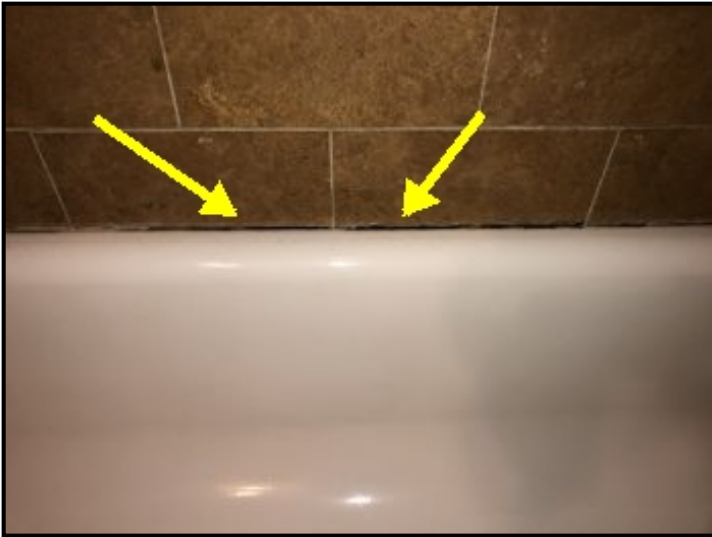
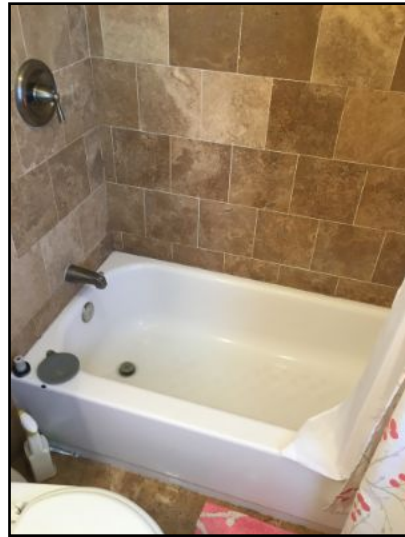
• There is damage to the porcelain finish on the cast iron tub in the upstairs bathroom. Due to condition, repair of porcelain finish may be needed in the near future.

staining f grout

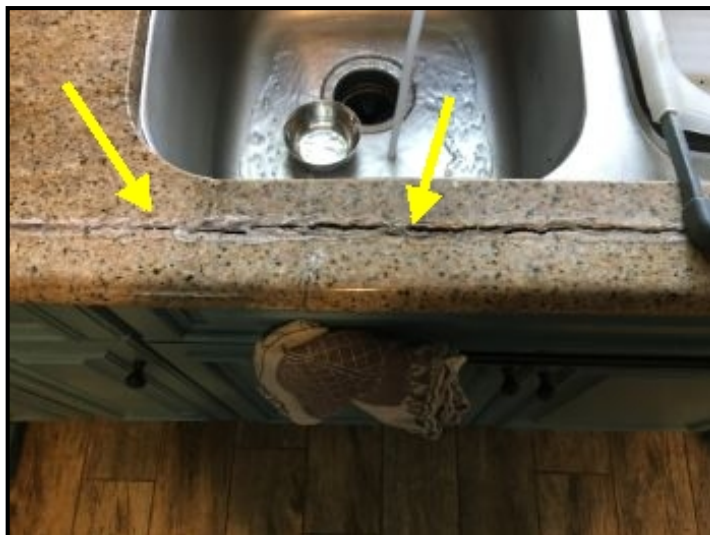
- Granite tops noted.
- Damaged counter top at front of sink. Recommend having a qualified contractor repair/replace as needed.

damaged counter top

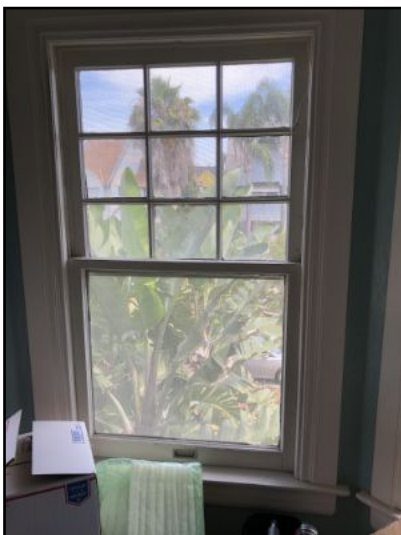
- Some of the older wood framed windows have broken balances. The balance holds the window in open position. Recommend having a qualified window contractor further evaluate and repair/replace as needed.
- Deterioration of the old wooden framed windows noted. While basic maintenance may prolong the life of these window frames, replacement may be necessary at some point.

balance broken at older window

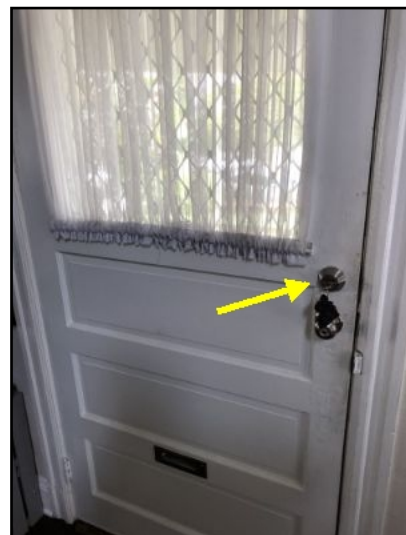
- The patio double doors are in good condition and operable.
- The front door has a double-sided keyed dead bolt lock set. This type of lock requires a key to unlock the door from the inside and can present an obstacle to anyone trying to evacuate the home in the event of a fire. Recommend replacing keyed lock set at interior of door with a thumb turn lock.

double keyed front door

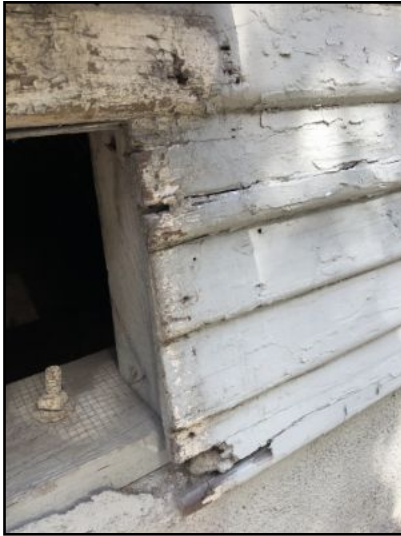
- The wood siding is very old, and there is excessive deterioration of the wood at several locations around the perimeter of the home. Recommend consulting termite inspection report for additional information, and all details pertaining to repair, replacement and/or treatment be completed by a qualified contractor.

wood siding deterioration

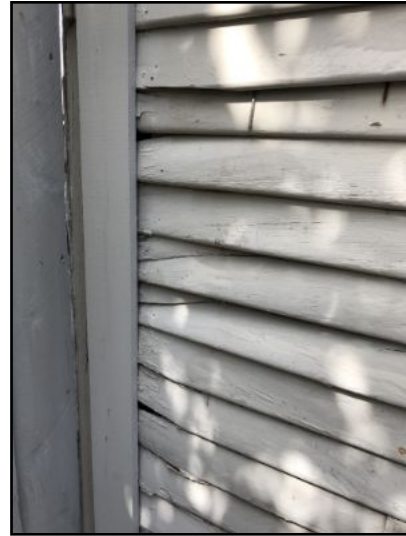
deterioration of wood siding

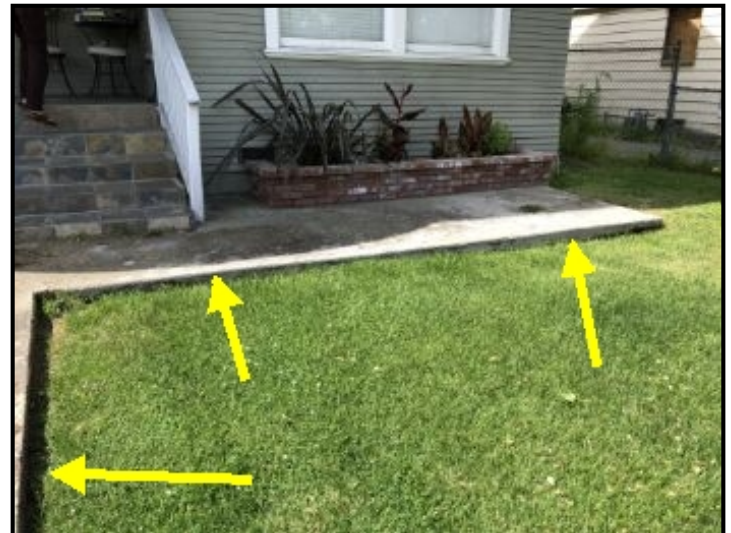
- The concrete walk is uneven with the driveway, and uneven with the front lawn. These locations are potential tripping hazards. Recommend having a qualified contractor further evaluate and repair tripping hazards for safety.

trip hazard

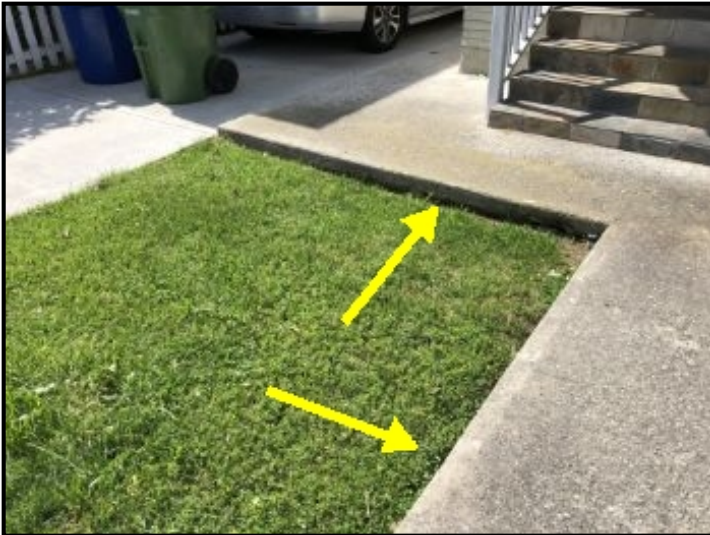
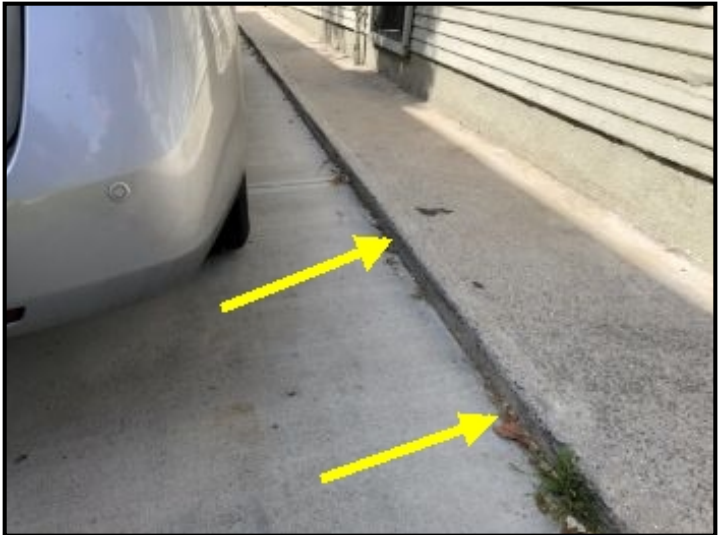
trip hazards

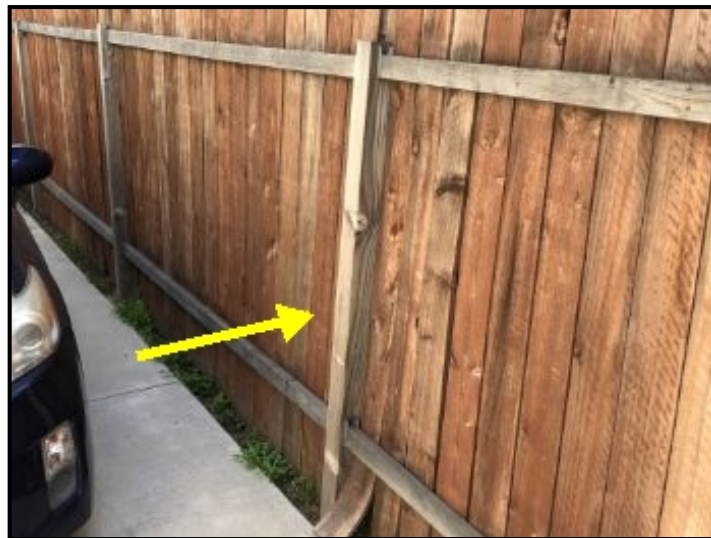
- A section of the wood fence along the left side of the property is loose and there is general deterioration observed. Due to condition, repair or replacement may be needed in the near future. Recommend having a qualified contractor further evaluate and repair or replace as needed.

loose fence

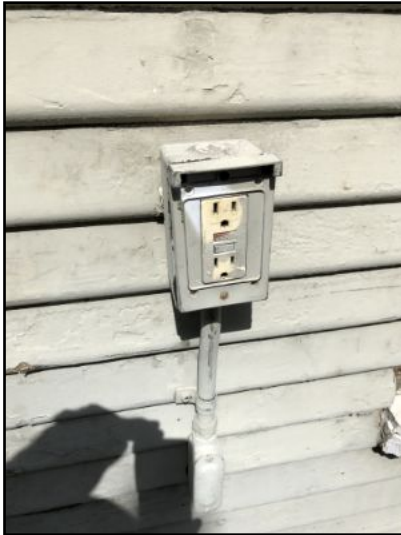
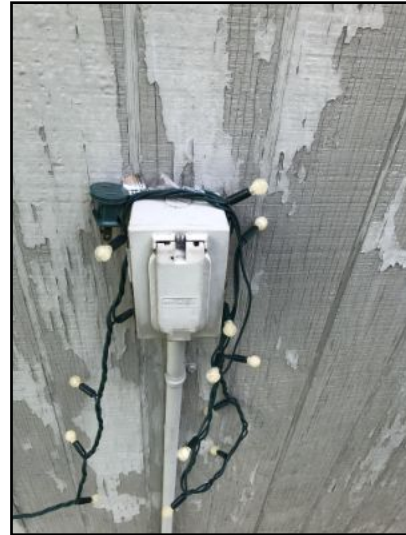
- The exterior receptacles do not have the current industry standard required weatherproof covers. Exterior receptacles installed in a wet location shall have an enclosure that is weatherproof whether or not an electrical cord is inserted.
- Loose electrical receptacle junction box found. The constant movement of loose electrical receptacle can loosen the wires connected to the receptacle and create dangerous arcing.
- The exterior GFCI receptacle located at the side of garage did not shut off when tested. This is a safety concern and should be corrected. Recommend having a qualified electrical contractor further evaluate the exterior electrical and repair as needed for safety.

broken weather cover - along the driveway side of home

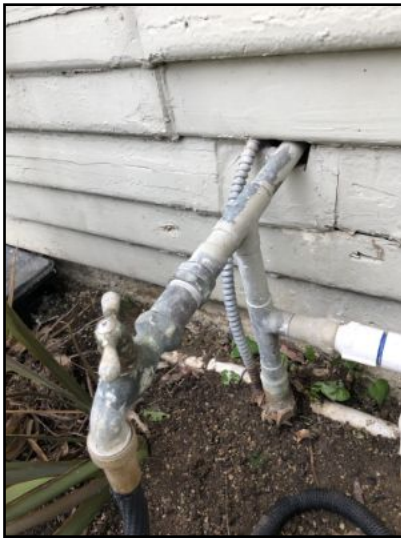
- The spigot at the front of the home has a stem leak. This is usually caused by a loose packing nut or a bad packing washer. Recommend having a qualified plumbing contractor repair.
- No anti-siphon devices installed on exterior faucets. An antisiphon device (or vacuum breaker) prevents unsanitary water from being pulled back through a garden hose and contaminating your water system, and they are current industry standard. Recommend having a qualified contractor install as needed.

No anti-siphon device

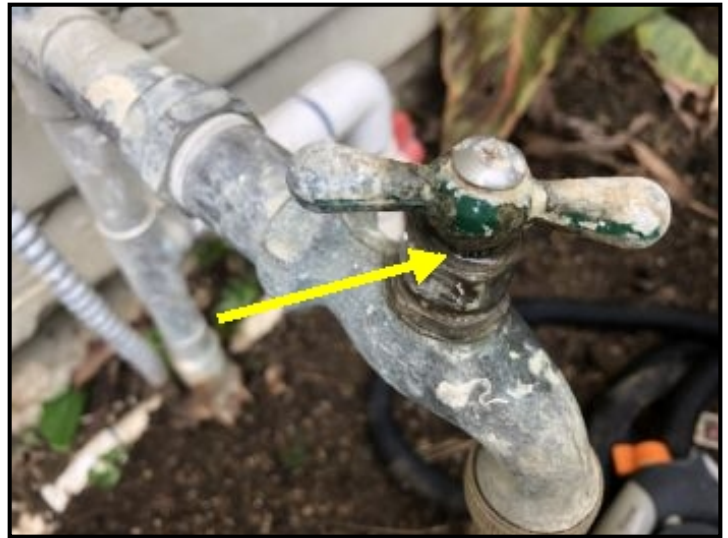
stem leak

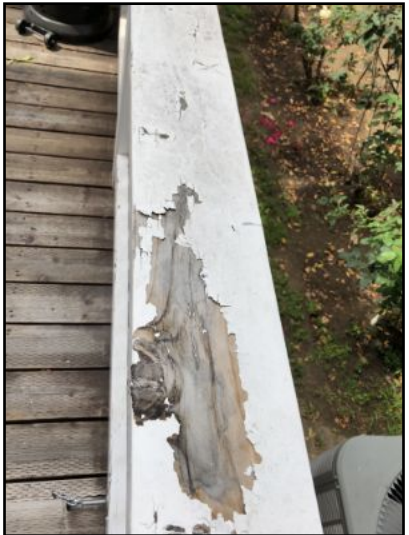
paint needed at railing

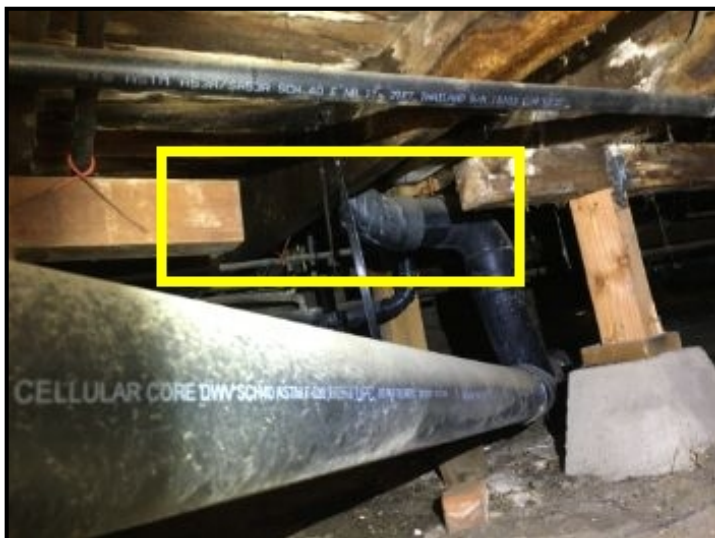
• In the crawlspace, there has been a section of girder cut out and there is no replacement support for floor joists at the location. This can be found by the plumbing under the main floor bathroom. Recommend having a qualified contractor further evaluate and repair as needed.

cut girder
