# PUNCHLIST

Flyhomes (Trina)  
1760 West 25th Street  
Los Angeles, California 90018

## Estimate

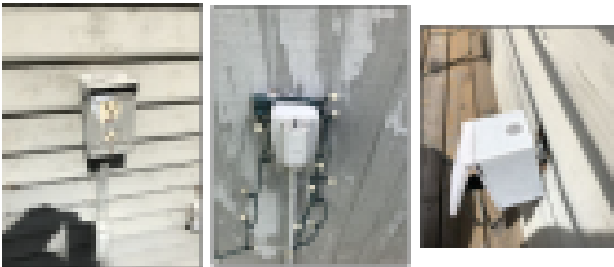
Exterior Outlets - Not Weather Rated - One or more exterior outlets are not weather rated. Inspector Description: The exterior receptacles do not have the current industry standard required weatherproof covers. Exterior receptacles installed in a wet location shall have an enclosure that is weatherproof whether or not an electrical cord is inserted.

### 374 - Install/replace weatherproof cover to exterior outlet(s).

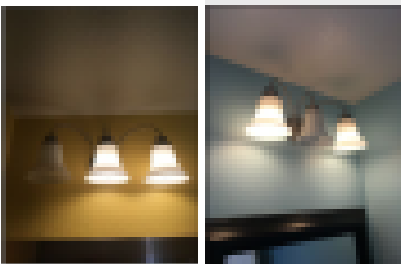
Light Inoperable - One or more lights are not operating. Inspector Description: Dead light bulbs in upstairs and downstairs bathroom vanity light fixtures. Checking/changing burned out/missing light bulbs is beyond the scope of this general home inspection. Recommend that light bulb(s) be replaced at any inoperable light and rechecked for proper operation before the close of escrow

### 369 - Replace light bulb(s).
