# Property Inspection Group

## Inspection Report

1760 W 25th St, Los Angeles, CA 90018  
Inspection prepared for: Flyhomes  
Date of Inspection: 6/1/2020 Time: 10:00 AM  
Age of Home: 1902 Size: 2286 SqFt

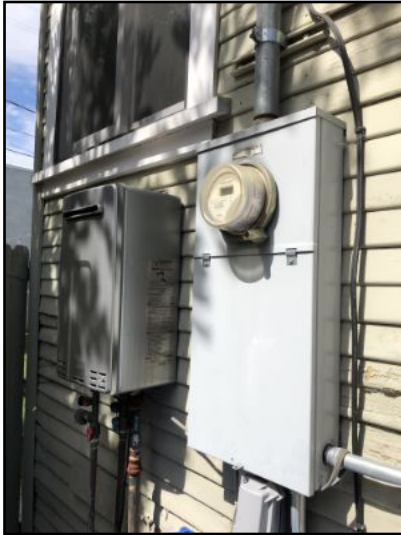
meter and panel

- There is a Murray 200 amp service panel present. The panel appears to be in good condition. Note that there are slots available for any future electrical expansion needs.

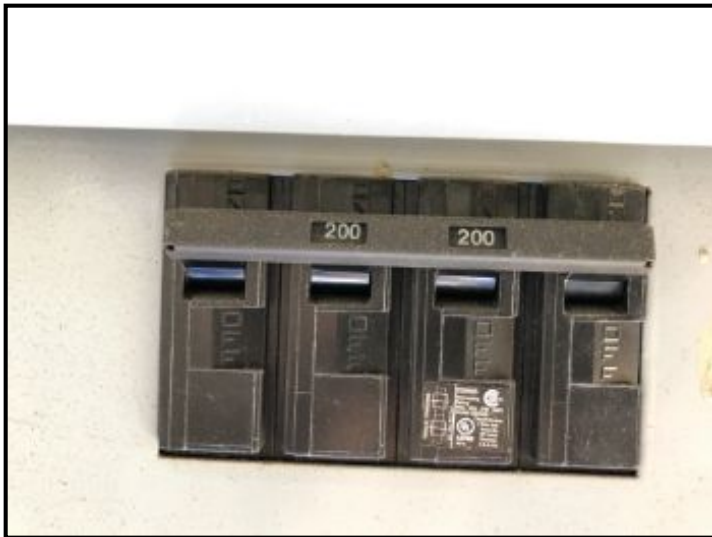
200 AMP main breaker

- All of the circuit breakers appeared serviceable.

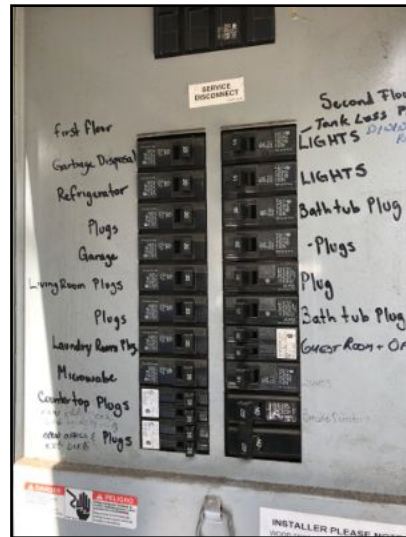
breakers labeled

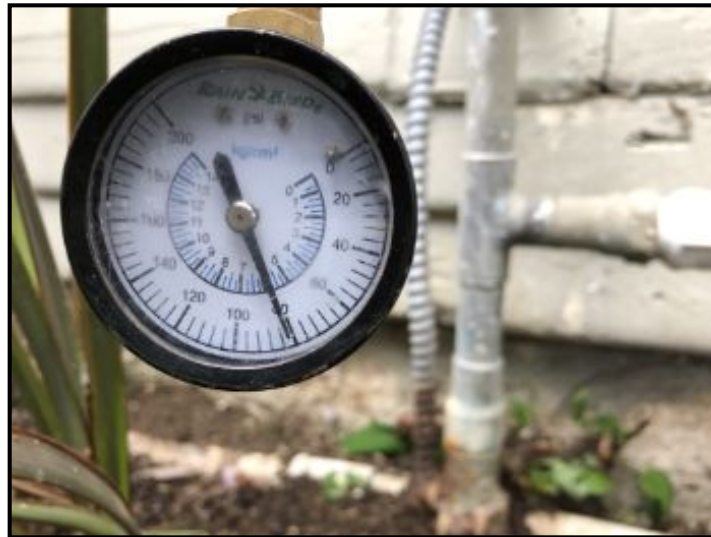
- The water pressure was 80 PSI at the time of inspection. This is acceptable and within the 40-80 PSI range suggested by local water authority.

Approximately 80 PSI

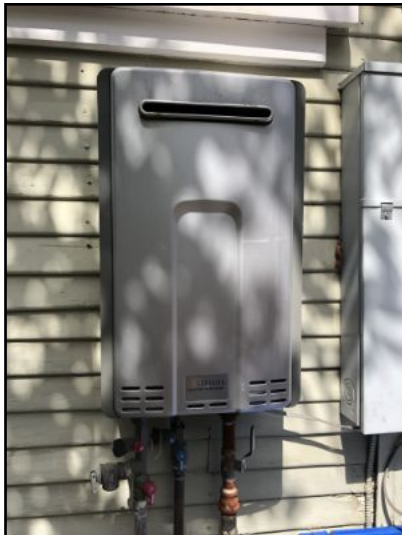
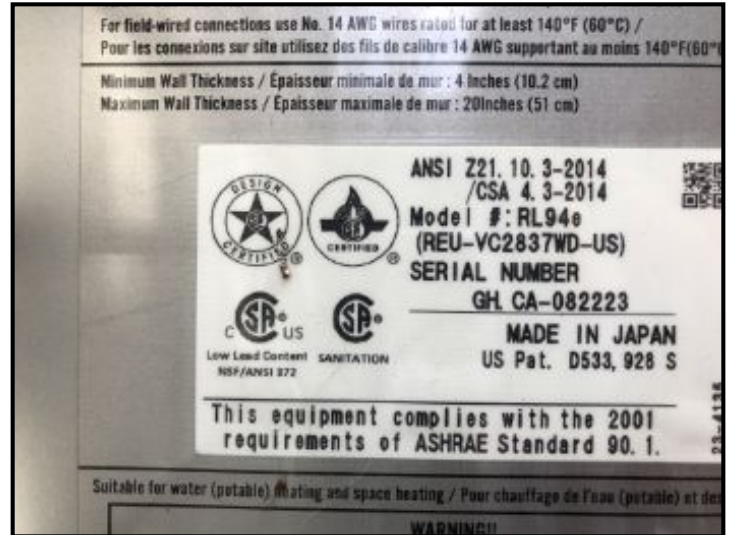
Rinnai tankless data plate

- The Rinnai tankless water heater working at time of inspection, and the unit is only 5 years old.
- Most manufacturers recommend that the tankless water heater should be flushed at least annually in order to eliminate the minerals and sediments that can affect the performance of the water heater. Recommend checking with the current owner as to the last time the tankless was flushed, and have a qualified tankless water heater contractor flush if neede

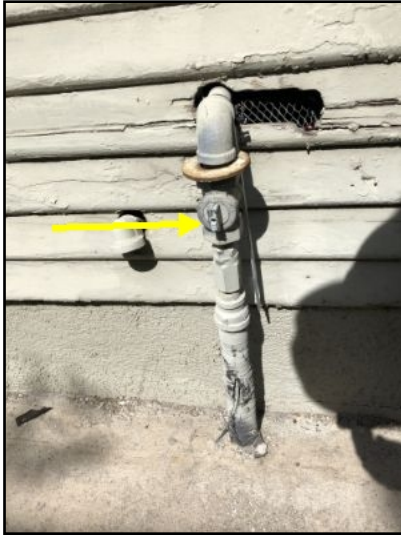
main gas shut off

- The gas meter and main gas valve appear to be in good condition.

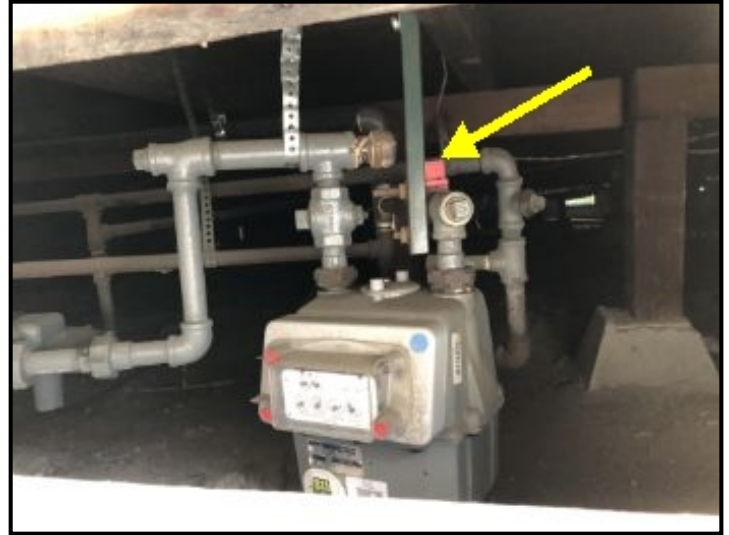
gas meter - note seismic auto shut off valve

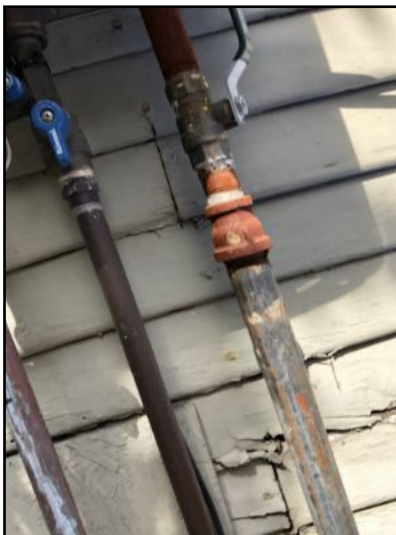
- The water heater gas line does not have a **sediment trap**. Note that industry standards state that a sediment trap is required, but the gas company claims that they are not needed since the gas is clean. What the sediment trap does is keep moisture and small particles from reaching the burner assembly. If the burner orifices get trash in them, the pilot or burner will not operate correctly. If the burner assembly is not operating correctly that could be dangerous. Recommend having a qualified contractor of the appropriate trade install sediment trap as required by standards.

gas shut off for tankless water heater - no sediment trap

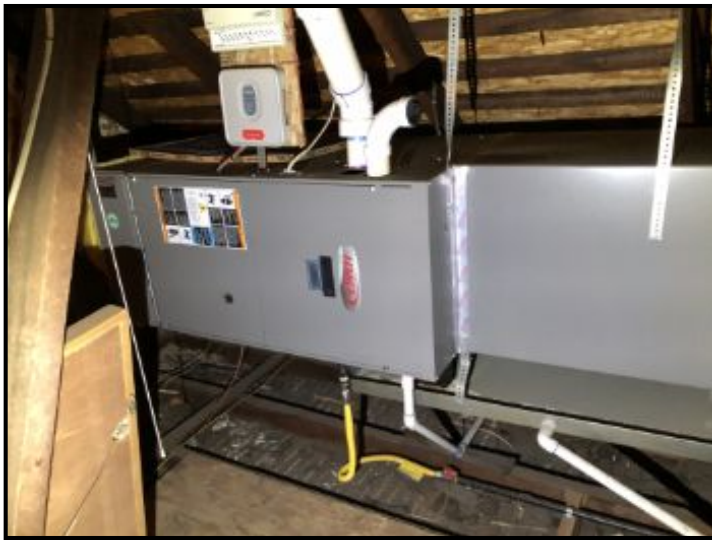
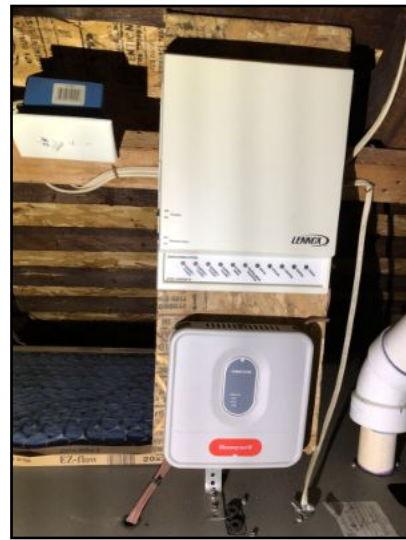
dual zone

- The Lennox gas furnace working properly at time of inspection. Note that the furnace is 10 years old, and the average design life is around 15-20 years.
- FYI - The HVAC system at this home is a dual-zone. It utilizes multiple sensors, thermostats, and modulating dampers to more effectively control the temperature between the upstairs and the downstairs within the home.
- Heating systems should be serviced annually, and this system is no exception. Recommend checking with the current owner about the last time it was serviced, and if it is overdue, have a qualified HVAC technician service the system.

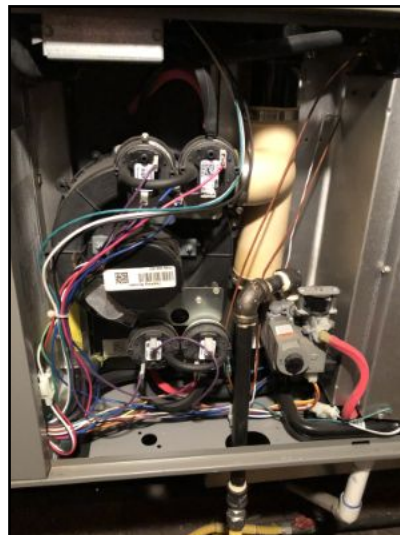
burner compartment clean

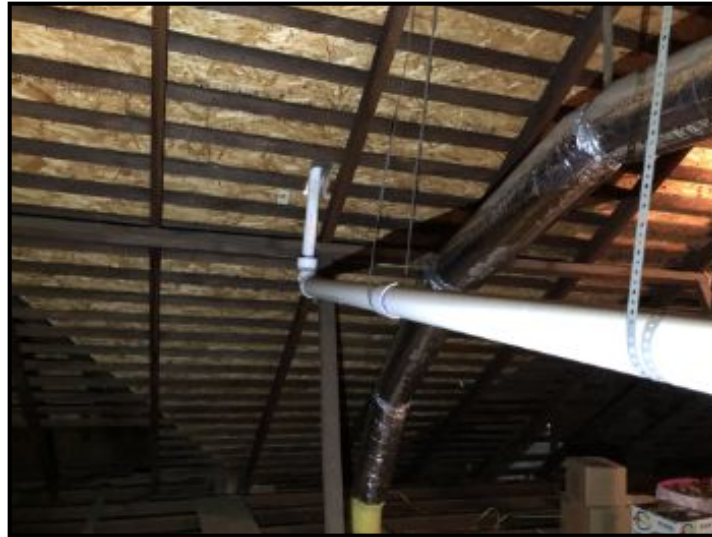
PVC venting

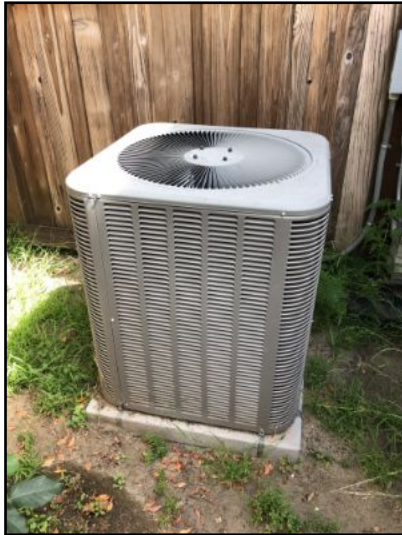
- The 5 ton Lennox cooling system working properly at time of inspection. Note that the cooling system is 10 years old, and the average design life for this type of unit is 15-20 years.

5 ton unit - 10 years old

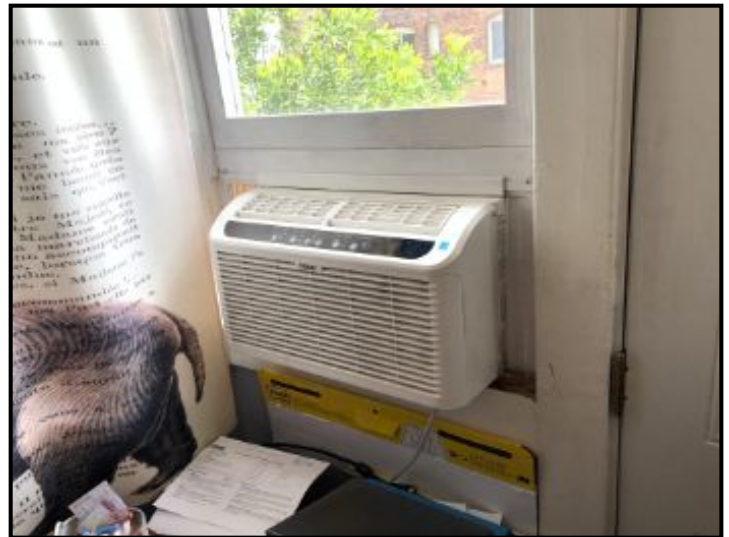
wall unit not tested

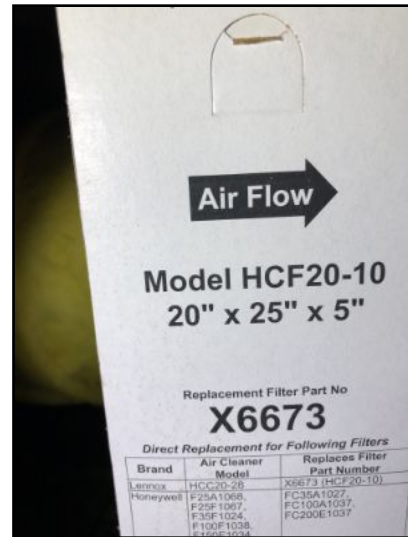
filter size - 20x25x5

Page 17 Item: 7	Filters	<ul style="list-style-type: none"> <li>The heating and cooling filter (located adjacent the forced air unit in the attic) is dirty. Recommend replacing the filter.</li> </ul>
Roof

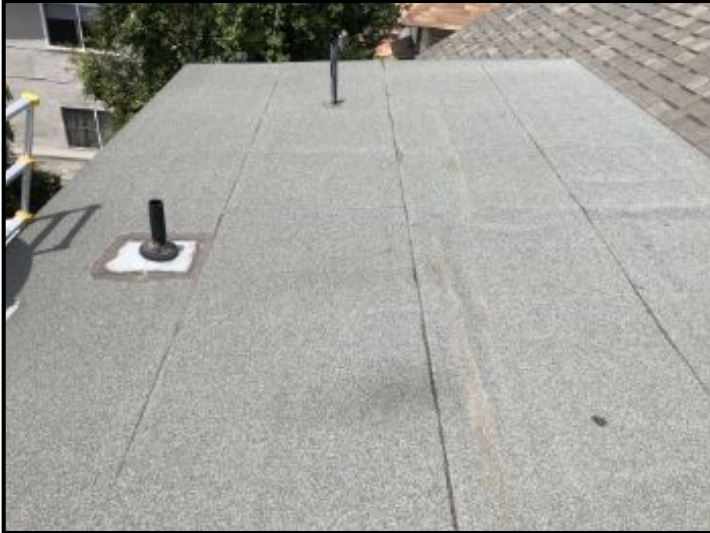
- The asphalt shingled roof and rolled roofing appear to be in fair condition.

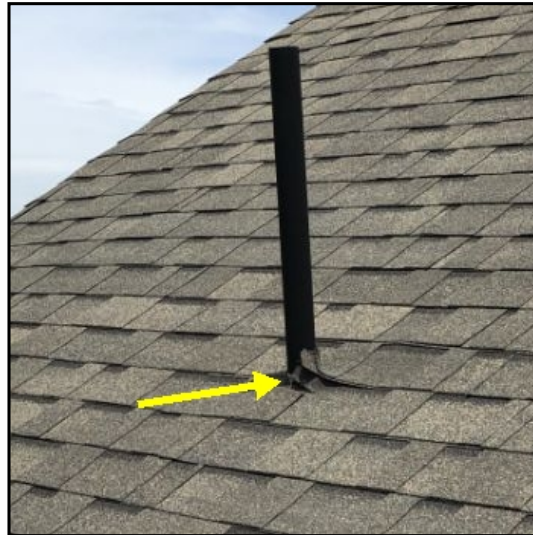
No flashing at ABS vent stack

Page 19 Item: 2	Flashing	<ul style="list-style-type: none"> <li>• Improper installation of two <b>ABS</b> vent stacks found on the back field of the roof. The vents protrude through the roof without any proper flashing. Recommend having a qualified roofing contractor further evaluate and correct as needed.</li> </ul>
Page 20 Item: 3	Chimney	<ul style="list-style-type: none"> <li>• Note that the older masonry chimney does not have a clay, ceramic, or metal chimney liners installed. Although there was not a requirement for the chimney liners when this home was built, current industry standards mandate liners. The chimney liners protect the house from heat transfer to combustibles; they protect the masonry from the corrosive byproducts of combustion; and they provide a correctly sized flue for optimum efficiency.</li> <li>• No chimney cap / spark arrestor installed at time of inspection. They are a California requirement. The chimney cap / spark arrestor keeps burning embers from escaping the fireplace, small animals from entering your home, and protects the interior lining of a chimney as well as the interior of the firebox from water intrusion.</li> <li>• The step flashing and counter flashing around the brick chimney has excessive damage. Recommend having a qualified chimney specialist further evaluate the condition of the chimney and make repairs as needed.</li> </ul>

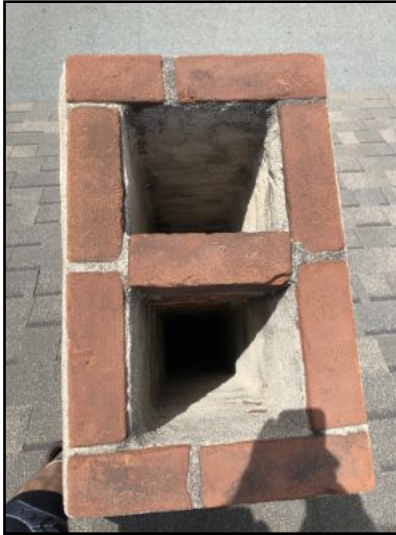
No liner - no cap /spark arrestor

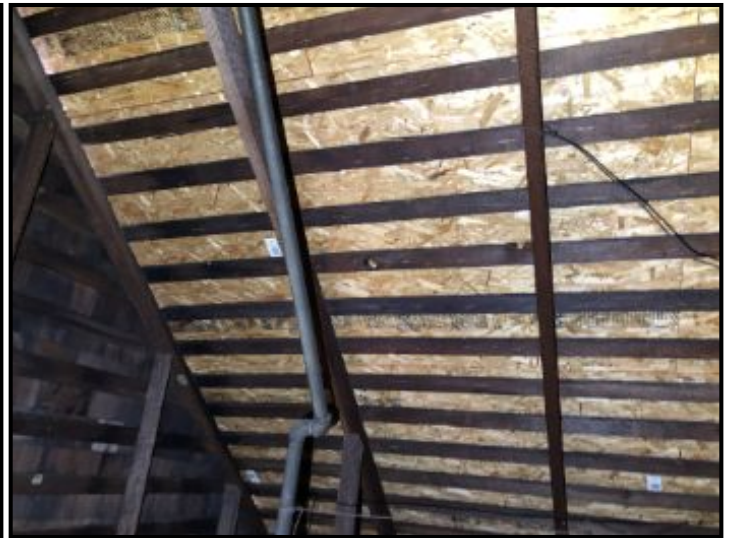
Spaced sheathing with OSB sheathing

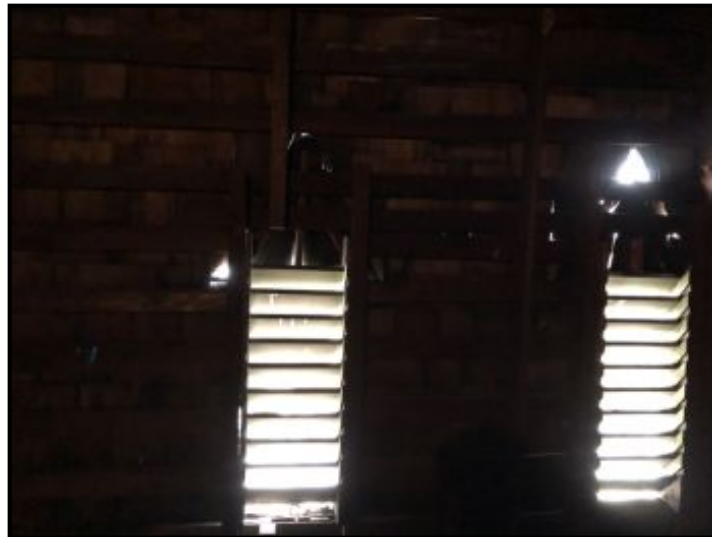
Gable ventilation

- Gable louver vents noted.

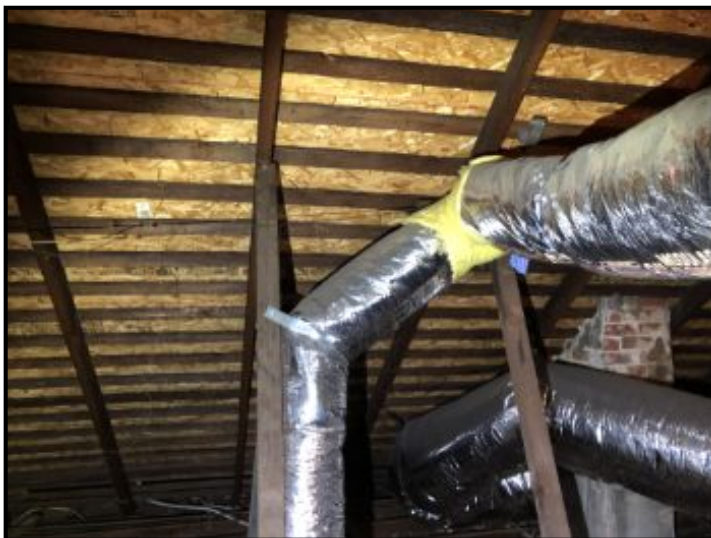
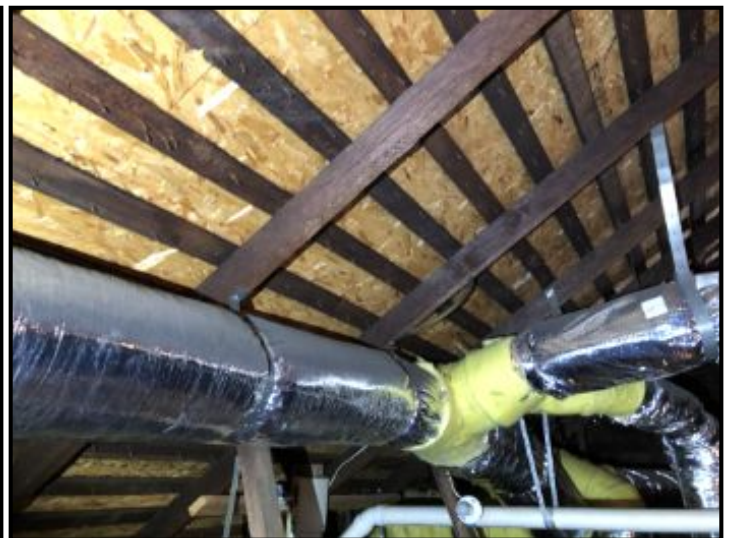
HVAC duct work

- The HVAC flexible duct work appears to be in good condition.

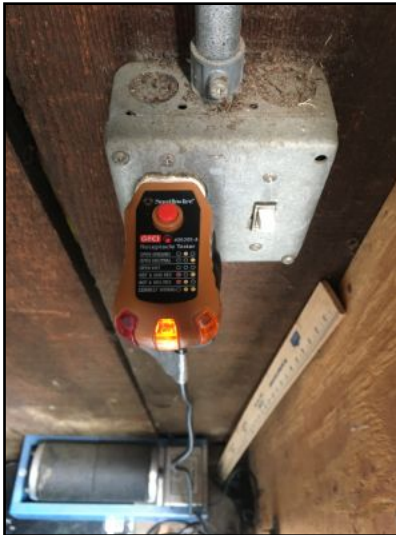
- Open ground at receptacle in the garage. This is a safety concern that should be fixed. There is a danger of possible shock or electrocution and damage to any equipment plugged into the receptacle.
- **GFCI** protected receptacles may not have been required when the house was built. The industry standard today is that all garage receptacles should be GFCI protected for safety. Recommend having a qualified electrical contractor correct the open ground, and upgrade all garage receptacles with GFCI for safety.

open ground

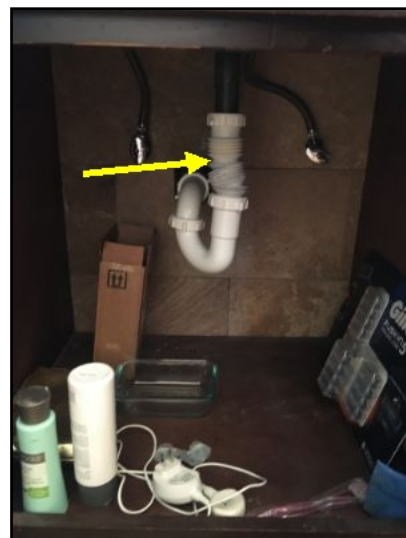
- Flexible, accordion style drain pipe is in use at the upstairs hall sink. Flexible plumbing pipes are not approved for installation by industry standards, which require that any waste pipe fitting have a smooth interior surface that allows the free flow of drain water and prevents waste buildup clogs.
- P-trap loose at upstairs bathroom. Recommend having a qualified plumbing contractor further evaluate and repair/replace plumbing as needed.
- There is minor corrosion of sink water shutoff valves at upstairs bathroom. Recommend monitoring, and have a qualified plumbing contractor replace shutoff valves before leaks do occur.

flexible plumbing

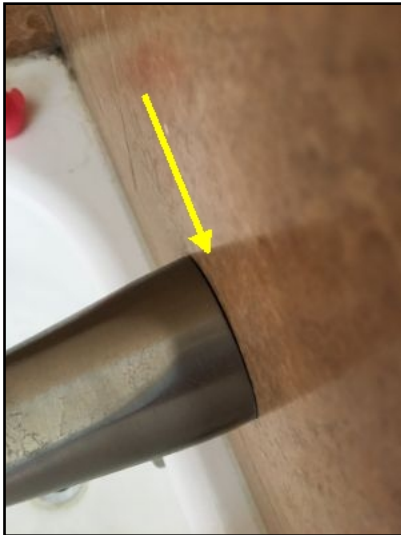
gap at faucet

- The upstairs and downstairs bathroom tub/shower faucets are not flush to the wall, which may result in water escaping behind the shower enclosure. This can cause deterioration, wood rot, and possible mold of the wood framing behind the tub/shower.

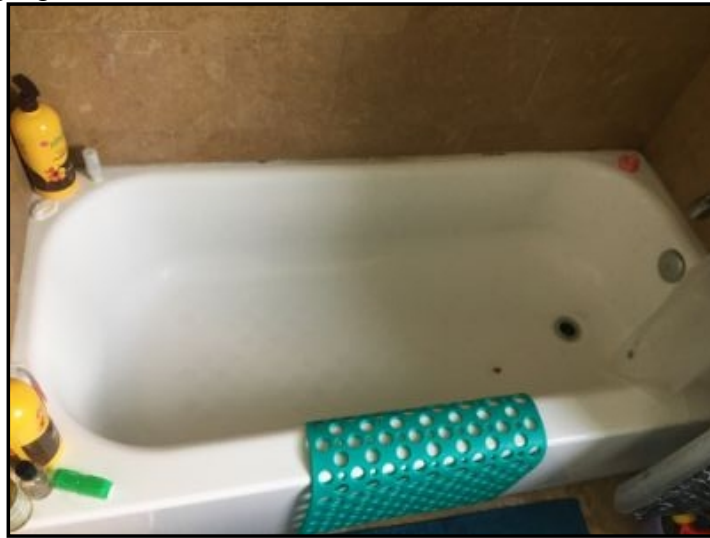
- The caulking along the bottom of the shower stall has black staining. Due to condition, scraping and replacing of caulking may be needed in the near future.

staining f grout

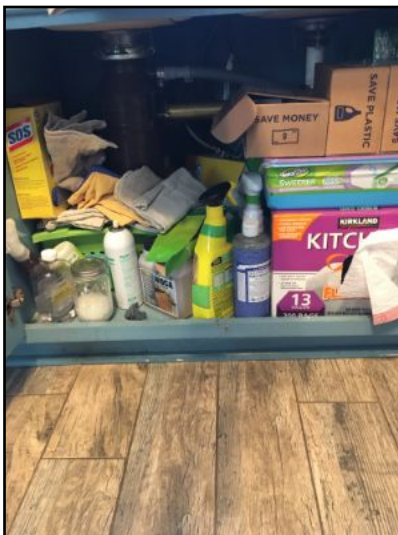
- There is very limited view of the cabinet under the kitchen sink due to belongings. Recommend having the owner remove all belongings and have the cabinet inspected before the close of escrow.

limited view

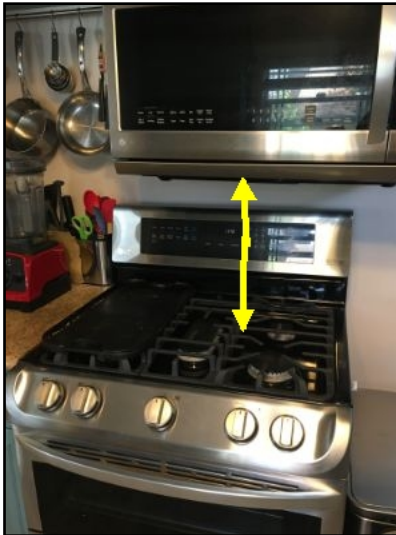
- Recirculating range hood present. Recirculating range hoods filter the air through grease and charcoal filters, and then reintroduce the air into the space.
- **The range exhaust unit is built into the microwave oven, and the bottom of the microwave oven is too low. California building standards specify that any range hood, including microwaves, installed above the stove must be a minimum of 24 inches away from the surface of the stove top if the hood is made of a noncombustible material. If the range hood or microwave is combustible, it must be installed a minimum of 30 inches away from the surface of the stove top.**

microwave too close to burners

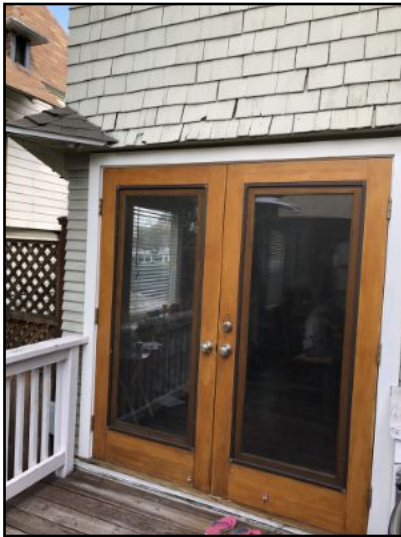
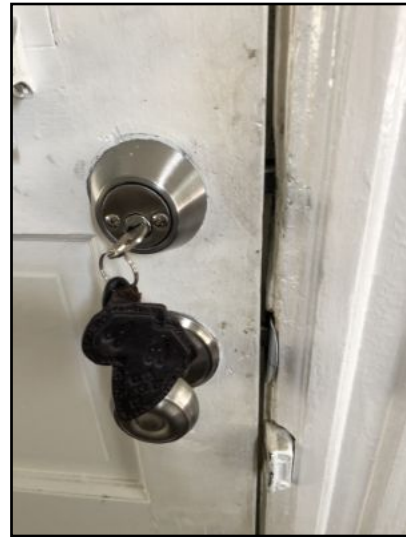
- The patio double doors are in good condition and operable.
- The front door has a double-sided keyed dead bolt lock set. This type of lock requires a key to unlock the door from the inside and can present an obstacle to anyone trying to evacuate the home in the event of a fire. Recommend replacing keyed lock set at interior of door with a thumb turn lock.

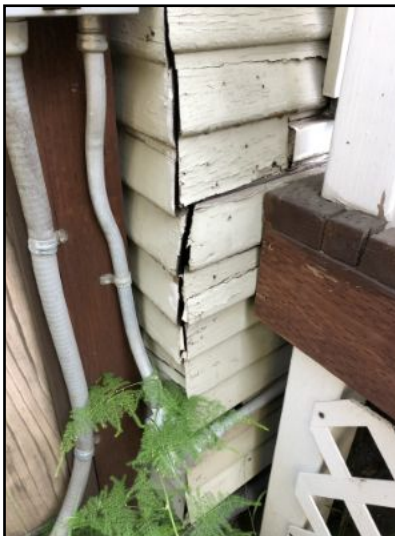
- The wood siding is very old, and there is excessive deterioration of the wood at several locations around the perimeter of the home. Recommend consulting termite inspection report for additional information, and all details pertaining to repair, replacement and/or treatment be completed by a qualified contractor.

Deterioration of wood siding

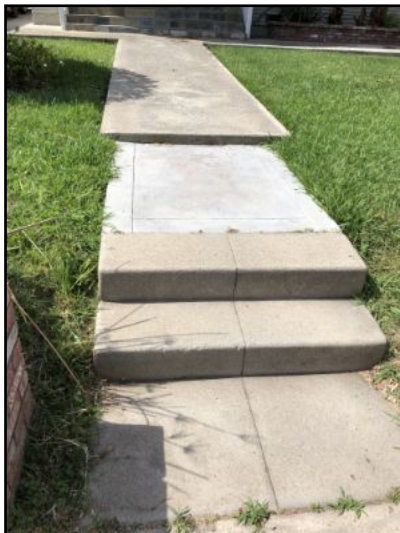
- The concrete walk is uneven with the driveway, and uneven with the front lawn. These locations are potential tripping hazards. Recommend having a qualified contractor further evaluate and repair tripping hazards for safety.

trip hazard

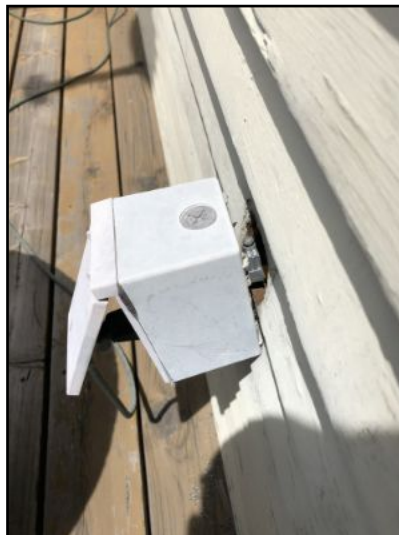
- The exterior receptacles do not have the current industry standard required weatherproof covers. Exterior receptacles installed in a wet location shall have an enclosure that is weatherproof whether or not an electrical cord is inserted.
- Loose electrical receptacle junction box found. The constant movement of loose electrical receptacle can loosen the wires connected to the receptacle and create dangerous arcing.
- The exterior GFCI receptacle located at the side of garage did not shut off when tested. This is a safety concern and should be corrected. Recommend having a qualified electrical contractor further evaluate the exterior electrical and repair as needed for safety.

loose receptacle

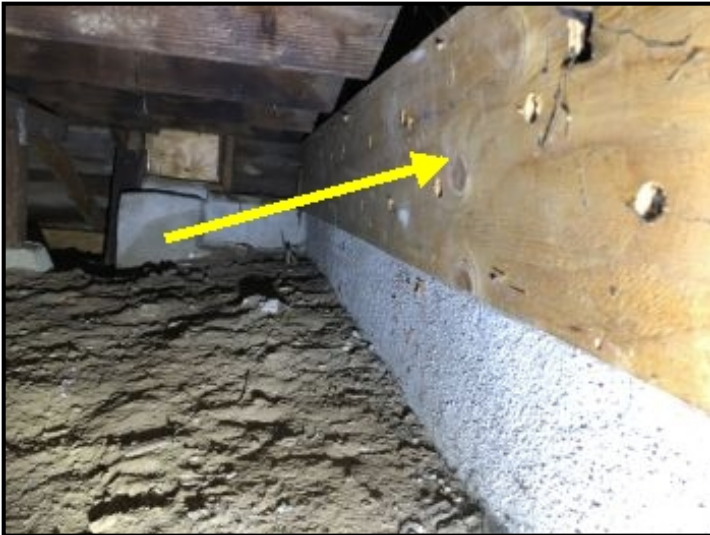
Plywood applied to cripple walls

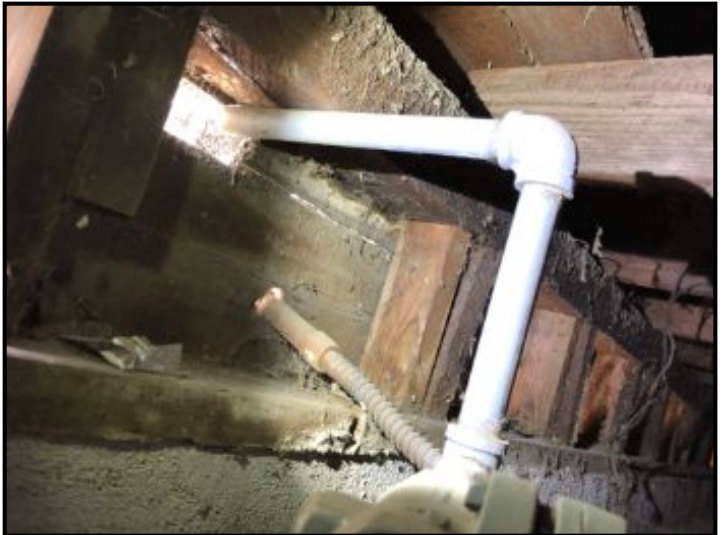
- This house does have plywood bracing at most of the cripple walls to further protect against earthquake damage. Cripple walls are braced by nailing plywood sheathing to the inside of the walls that surround the crawlspace.
- There has been seismic retrofitting of the cripple walls. This house does have plywood bracing on most of the cripple walls. The only place where seismic retrofitting does not appear to be taking place is along the eastern cripple wall (back half of wall). Recommend adding the additional plywood.

no plywood added on eastern wall in crawlspace

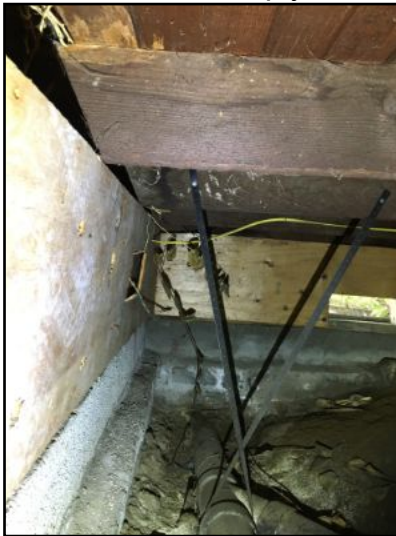
plywood applied at west and north walls

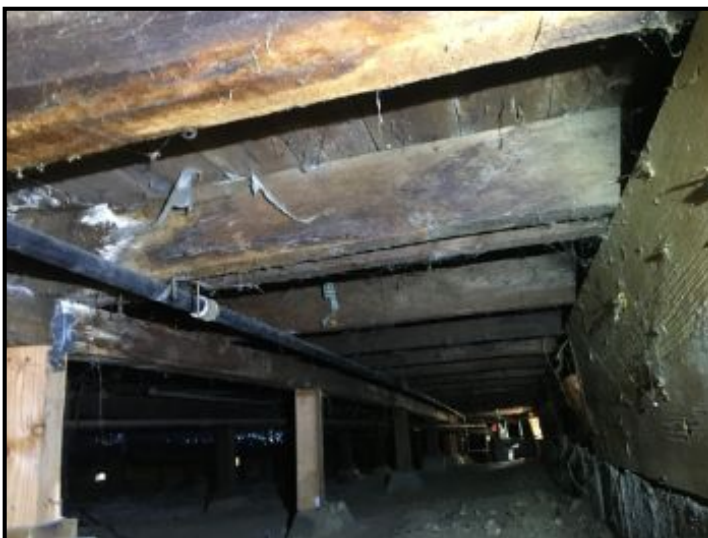
floor joists appear to be in fair condition
